Fryer Creek Beaver Impact Analysis and Alternatives Development Report

Prepared for:
Sonoma Water
404 Aviation Boulevard
Santa Rosa, CA. 95403

Prepared by:
Prunuske Chatham, Inc.
400 Morris Street
Sebastopol, CA. 95472

December 6, 2021

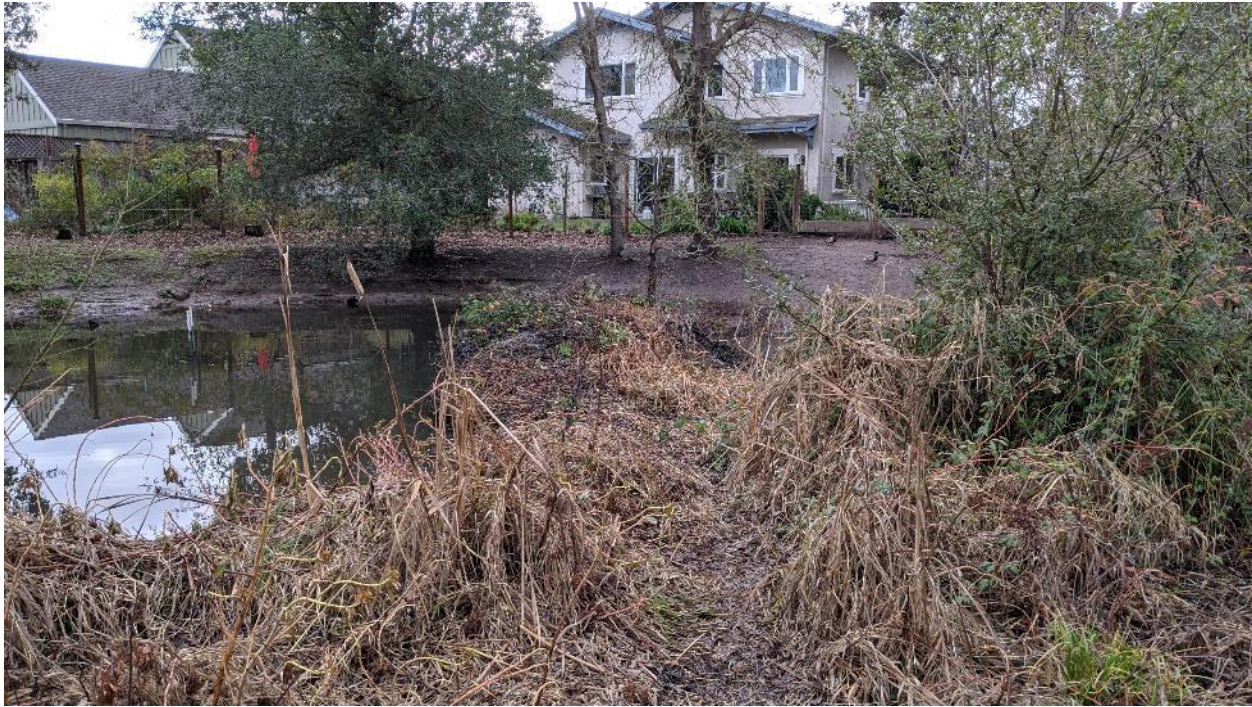
Figure 7a

Current Beaver Dam #1 with Flow Control Device (taken from right bank, flow from left to right)

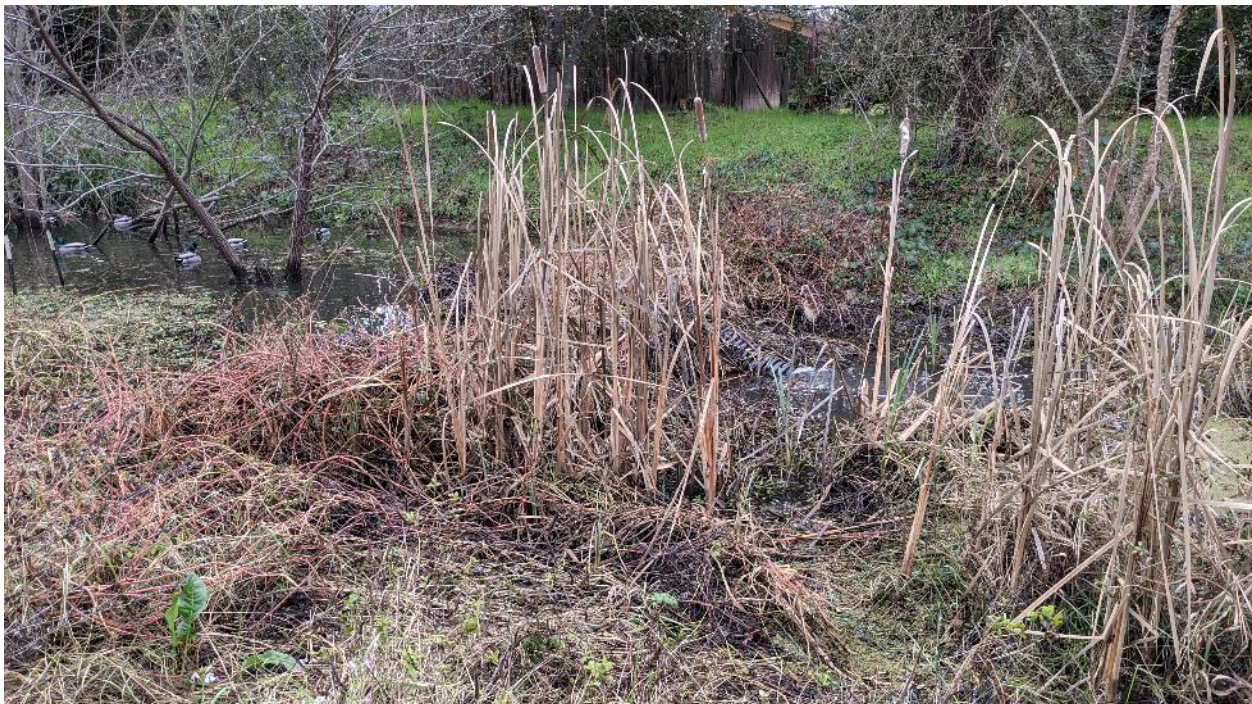
Figure 7b

Current Beaver Dam #2 with Flow Control Device (taken from right bank, flow from left to right)

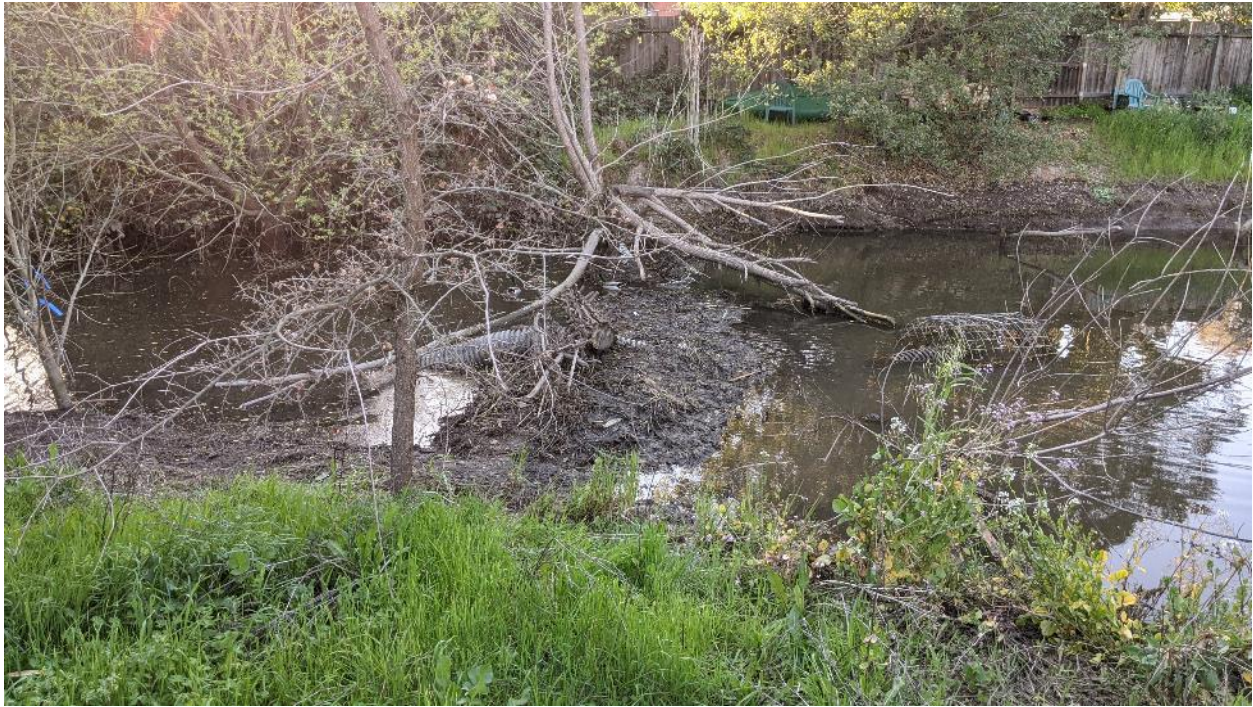
Figure 7c

Current Beaver Dam #3 with Flow Control Device (taken from left bank, flow from right to left)

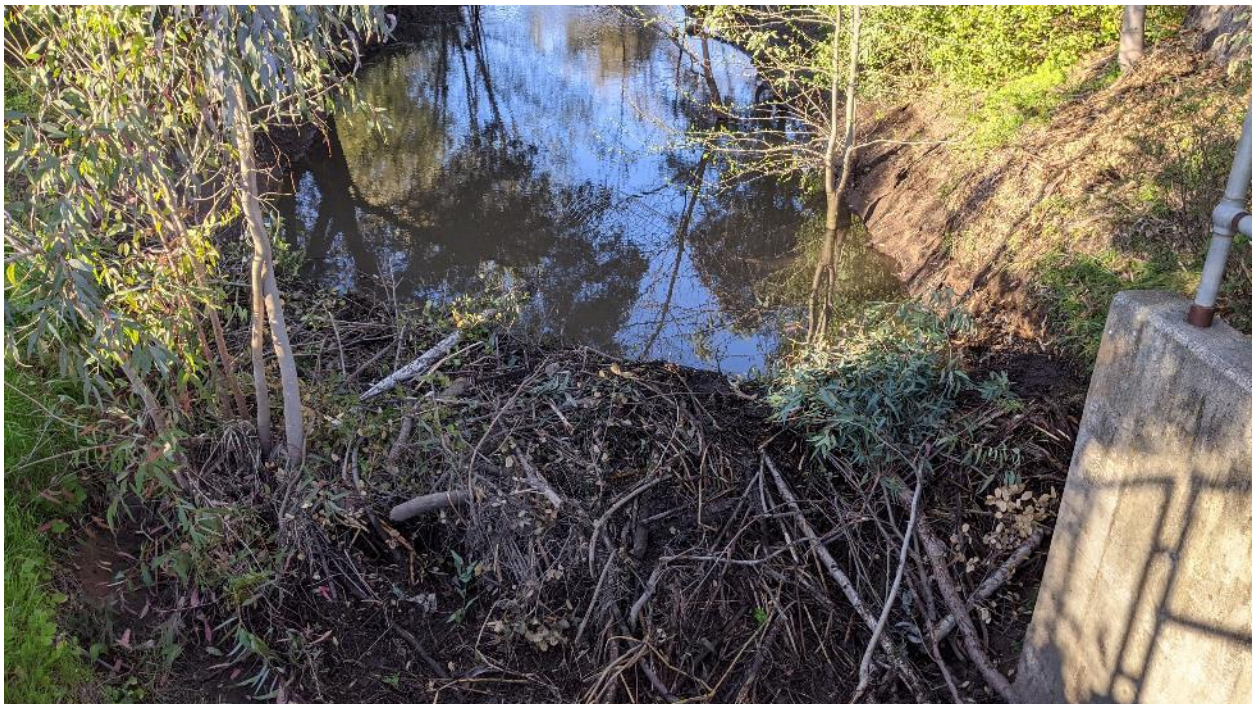
Figure 7d

Current Beaver Dam #4 with Flow Control Device (taken from W. MacArthur St. looking upstream)

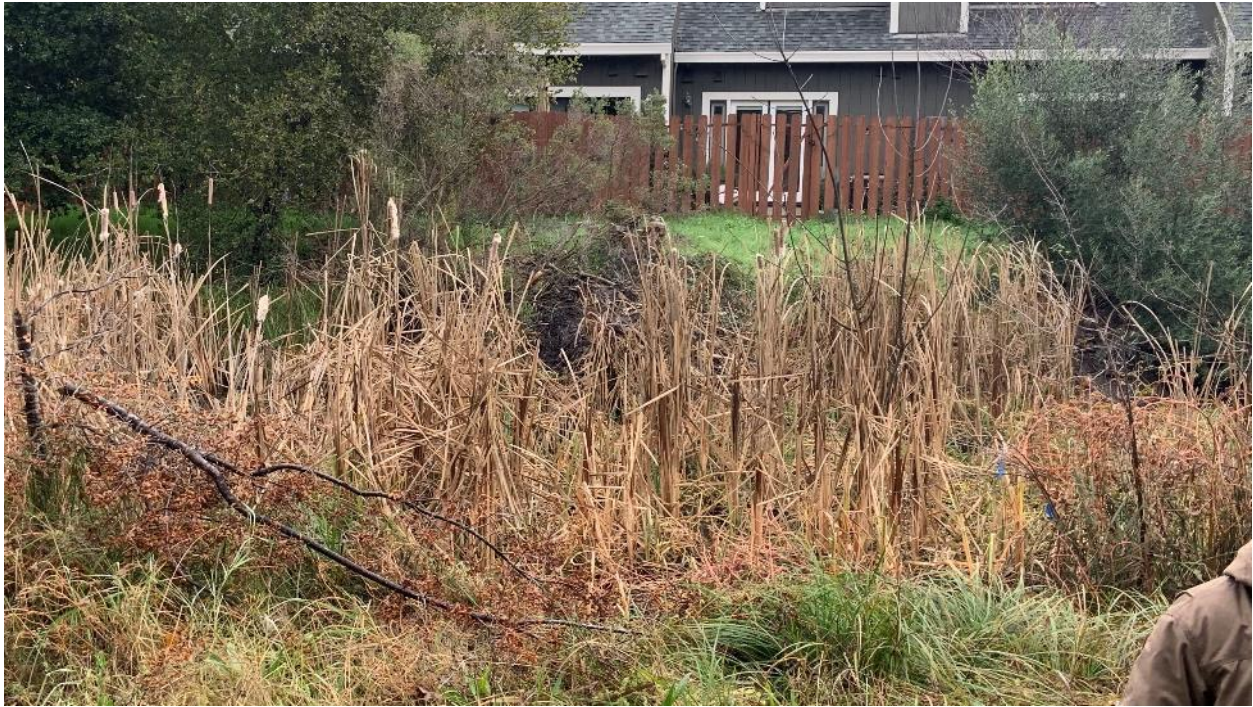
Upstream of the beaver dams, wetland vegetation is established throughout the low flow channel, including cattails and bulrush (see Photo 8a above). The slower flow, and resulting fine sediment deposits, above the dams provide favorable conditions for these emergent wetland species.

Figure 8a
Beaver Lodges on Left Bank (taken from right bank)

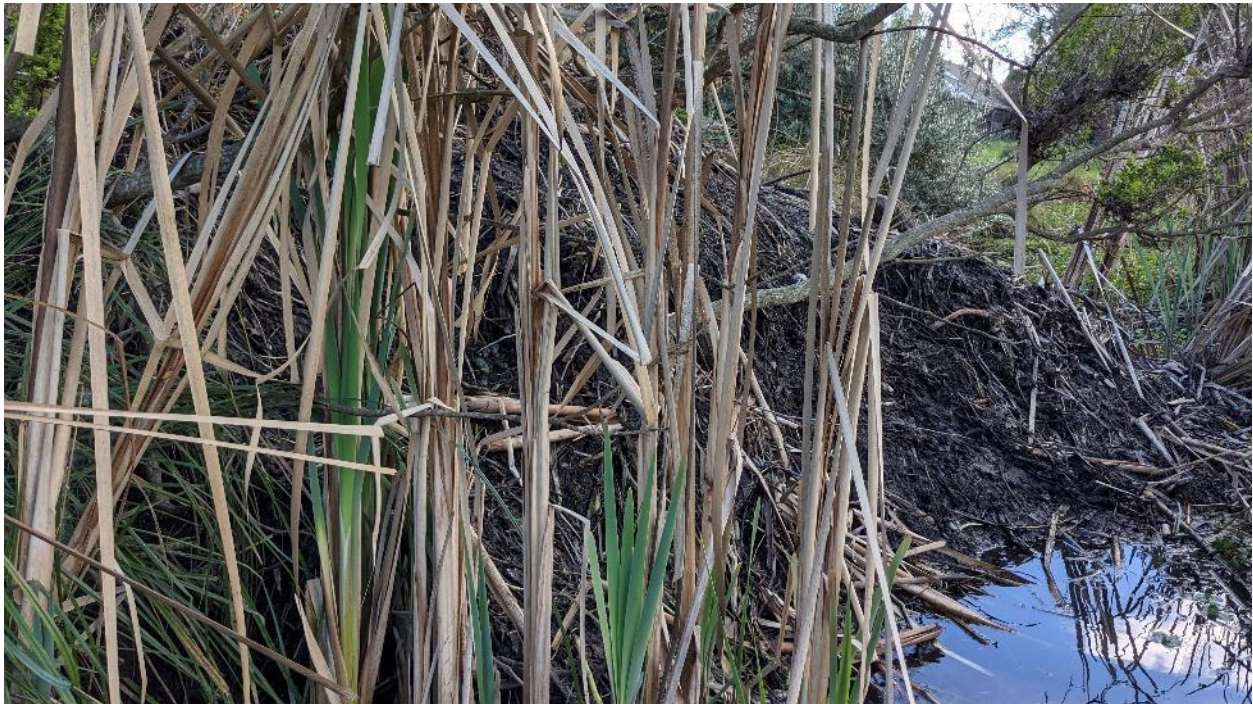
Figure 8b
Beaver Lodge Up-close (taken from left bank looking downstream)

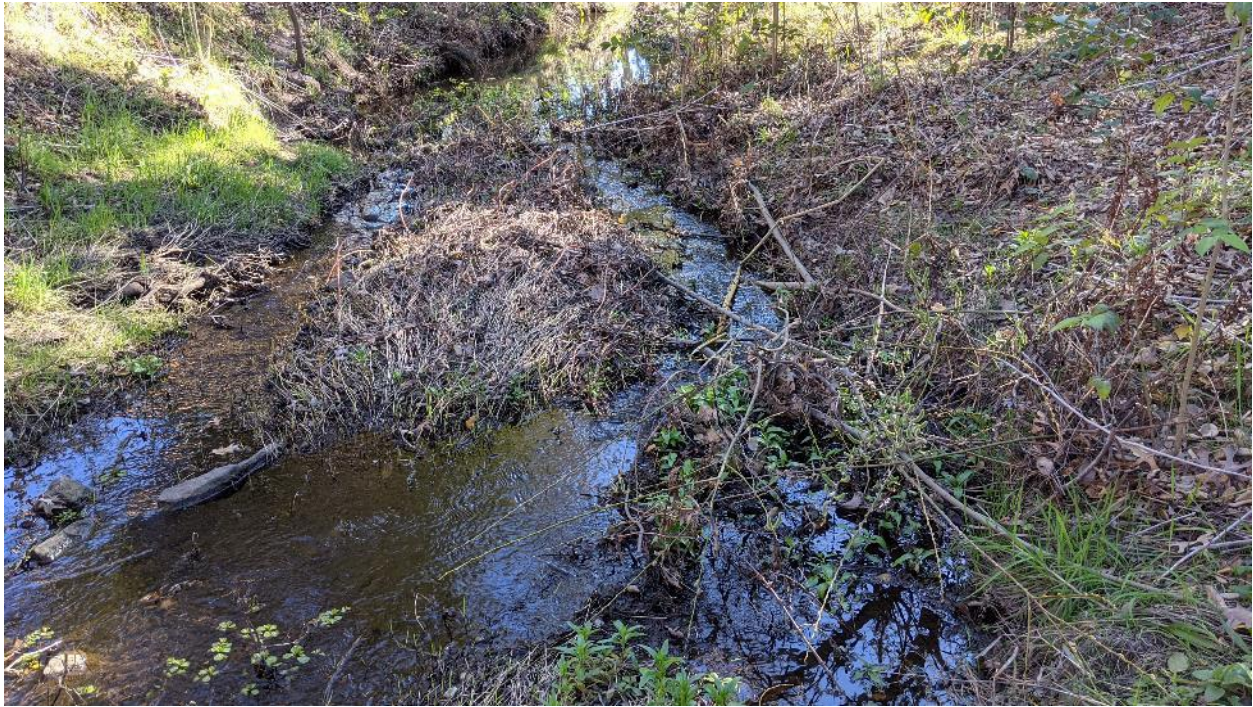
Figure 9a

Beaver Dam Activity Downstream of West MacArthur Street (taken from channel looking downstream)

Downstream of West MacArthur Street, the channel is particularly narrow and straight. It stands to reason that in such a confined channel, dams built by beavers in this location could fail. Building materials here are limited as well, and may consist of less-resistant grass, mud and small sticks. At Current Dam #4 just upstream of the West MacArthur Street culvert, the channel also begins to narrow creating a potential dam failure scenario. It's possible that the backwater caused by West MacArthur Street may prevent a failure of Current Dam #4 from happening. However, a failure of Current Dam #4 may result in the West MacArthur Street culvert getting clogged with debris, reducing flow conveyance capacity and exacerbating the backwater and flooding upstream of West MacArthur Street. For Current Dam #1 and #2, because of the added width from the maintenance road, there was less flow across the dams resulting in lower unit discharges.

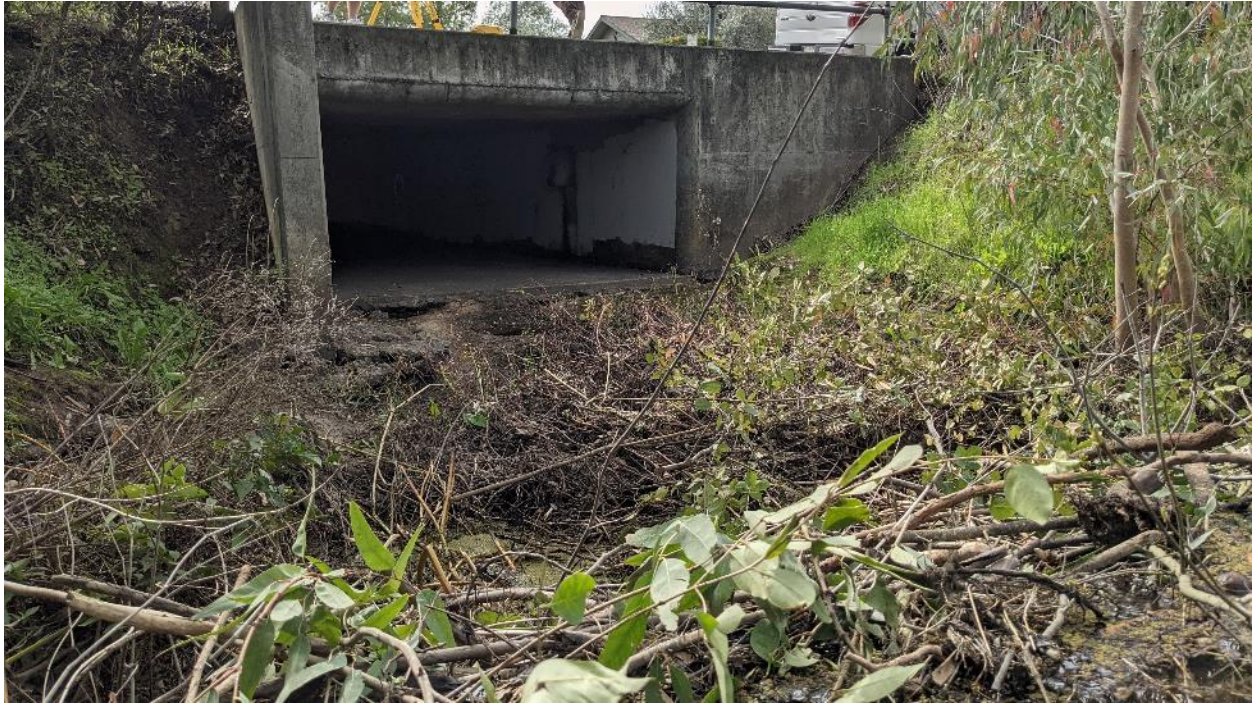
Figure 11a

Upstream of West MacArthur Street Culvert looking Downstream

MacArthur St crossing is undersized and, even without any blockage, significantly controls the peak flow water surface elevations upstream. Any reduction in flow capacity of the crossing will only worsen this condition. However, for material from a failed beaver dam to have a significant effect on flooding, the material would have to be capable of spanning the culvert opening while resisting a relatively large stream force. As most of the material in the beaver dams is relatively small, it would likely pass through the crossings, or potentially create a small partial blockage that would then be forced through during high flow events as velocity increases. PCI recommends taking steps to prevent blockages. Currently, the Project Area beavers have felled a red willow upstream of the McArthur St. crossing, which is a possible concern. Felled trees provide essential resources for beaver (for feeding on cambium, and sharpening teeth) while the trees are relatively fresh. However, Sonoma Water is concerned that if these are left in place they could block culverts in a storm, and prefers to remove them promptly. Sonoma Water has determined that it is not feasible to cut felled trees to smaller sizes (which could pass through the culvert) and leave them in place.

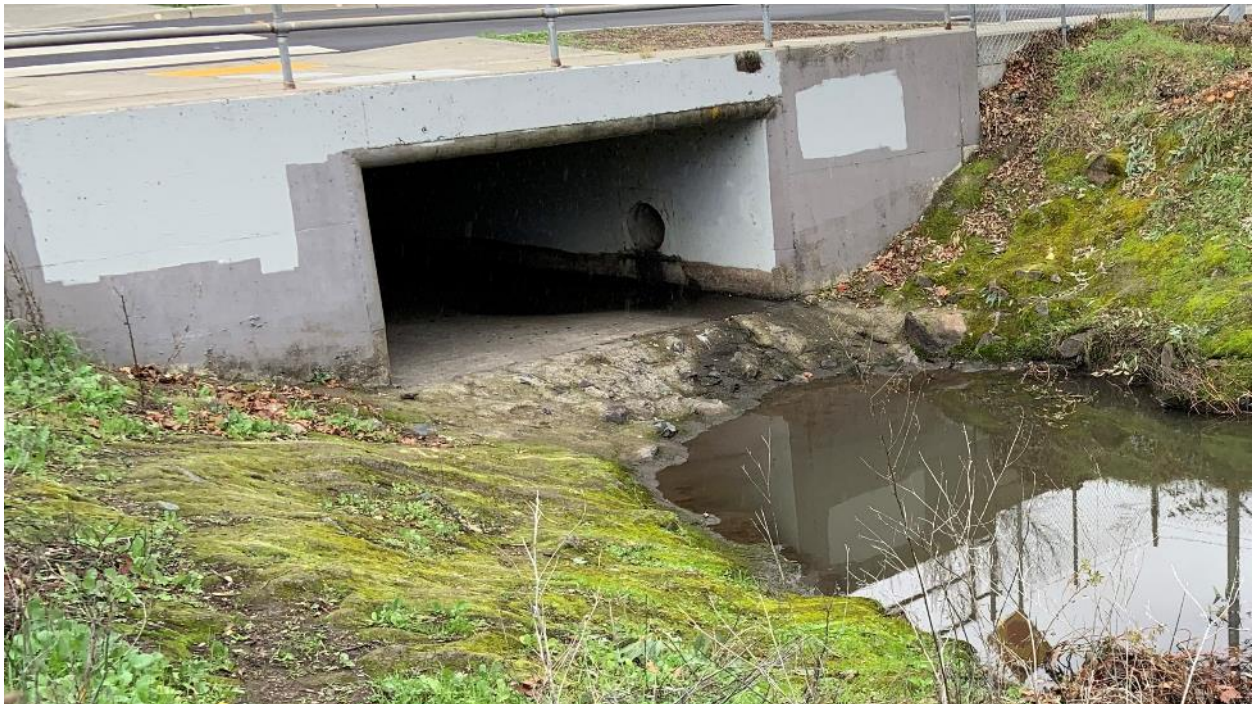
Figure 11b

Downstream of West MacArthur Street Culvert looking Upstream

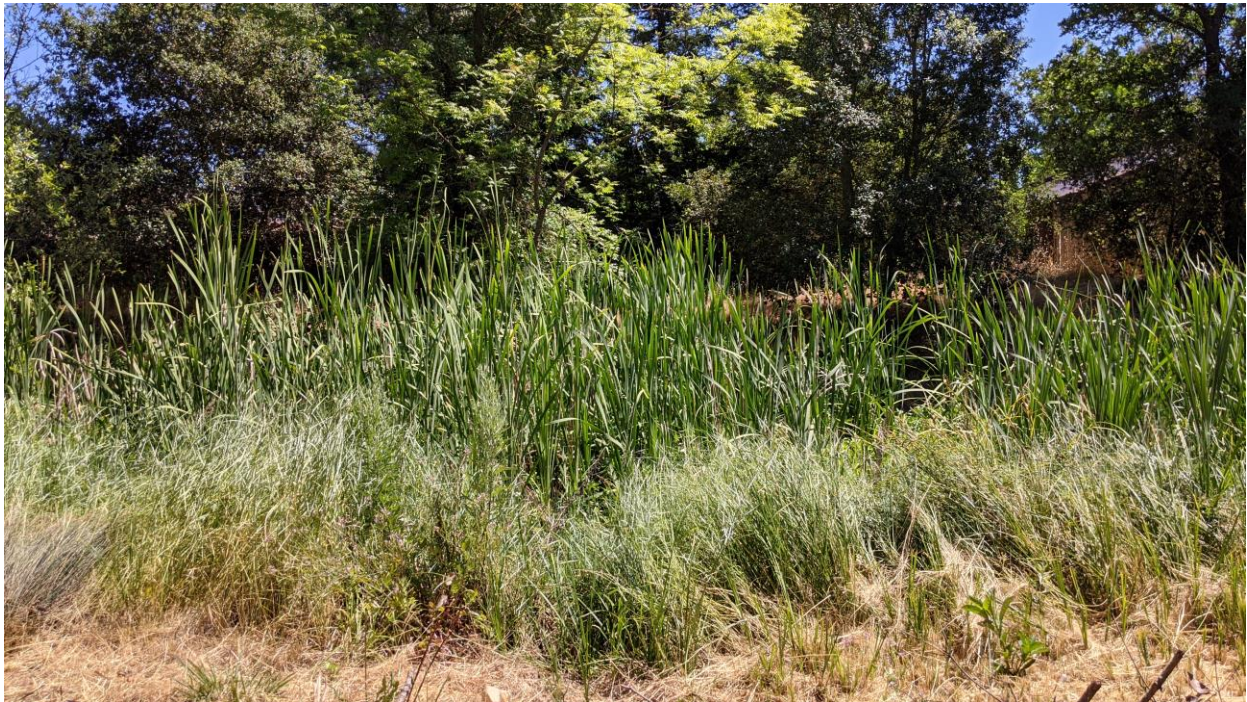
Alternative 2 analyzed the impact that full cattail establishment within the low flow channel would have on hydraulics. (Note that this is not a recommended condition, but rather a theoretical condition for analysis purposes; see Section 5 for management recommendations relating to cattail.) Beaver dams have been shown to facilitate the establishment of wetland vegetation upstream of the dams in areas experiencing increased ponding (Pollock et al., 2018; Lundquist and Dolman, 2018). Currently, cattails have become established at various locations in the low flow channel upstream of W. MacArthur St. (**Figure 19**). Cattails can grow up to 9 feet tall which is well above the surrounding topography. This alternative assumes the worst case scenario in which the cattails do not lay over, causing a drastic increase in flow roughness or obstruction of flow. Research by the U.S. Army Corp of Engineers' Wetlands Research Program found that Manning's n roughness values level off between 0.18 (observed) and 0.27 (calculated) at the highest velocities (Hall and Freeman, 1994). Thus for Alternative 2, a Manning's roughness value of 0.2 was used in the hydraulic model below the elevations of the beaver dams for the entire active channel (not including culverts) in both forks of Fryer Creek upstream of Future Dam #7.

Figure 19
Established cattails in the Fryer Creek East Fork low flow channel

The main management implication of the analysis of Alternatives 1a, 1b, and 2 for Sonoma Water is the possible need for increased monitoring and maintenance. The findings for Alternatives 1a and 1b suggest an increased need for monitoring to ensure new dams are identified early. Flow control devices should be monitored regularly, including after large storm events, to ensure that they are clear and in proper working order. In particular, inlet protection cages need to be inspected for potential damage or plugging after larger storms where bedload or vegetative debris have been transported by the stream. It appears there is some room for the dams to go undiscovered, but once the dams reach a typical maximum height of 6 feet they may prove to be problematic for meeting designed flood freeboard requirements. The analysis of Alternative 2 indicates the potential need to perform more regular vegetation clearing in the channel. Cattails are a source of food for beavers so some balance will need to be considered between vegetation clearing and maintaining resources for beavers.

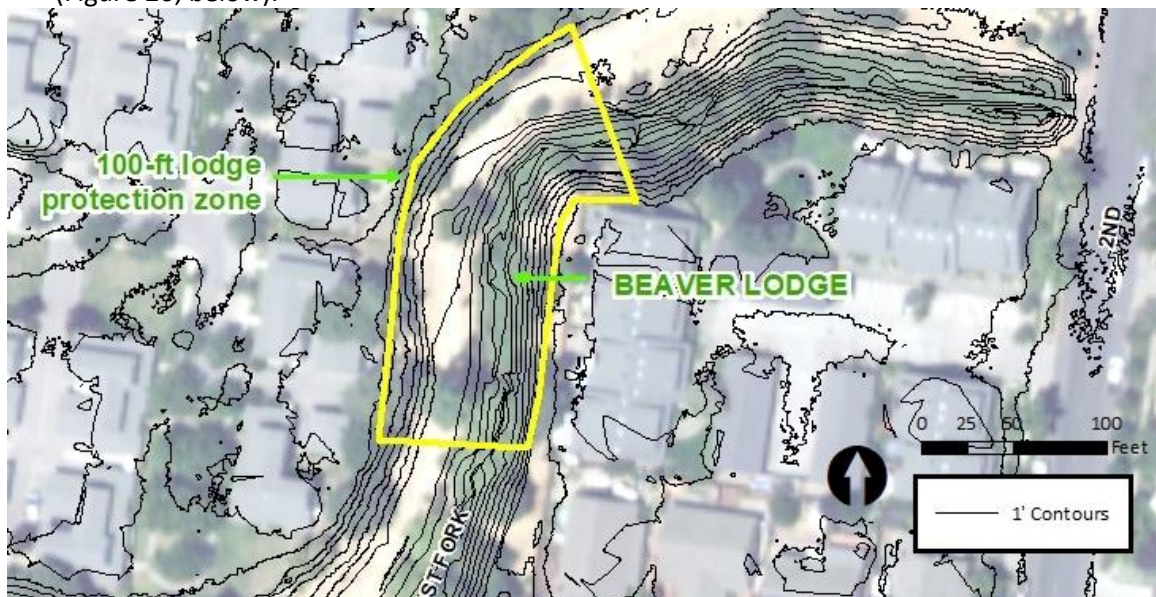
Figure 20. 100-foot zone around current Fryer Creek beaver lodge, for protection of beaver from stream maintenance activities

1. Designate the area within a 100-foot radius of the beaver's bank burrow (lodge) as "sensitive" (Figure 20, below).

2. Use landscaping flags on the banks to help work crews identify where this area begins and ends.
