Fryer Creek Beaver Impact Analysis and Alternatives Development Report

Prepared for:
Sonoma Water
404 Aviation Boulevard
Santa Rosa, CA. 95403

Prepared by:
Prunuske Chatham, Inc.
400 Morris Street
Sebastopol, CA. 95472

December 6, 2021

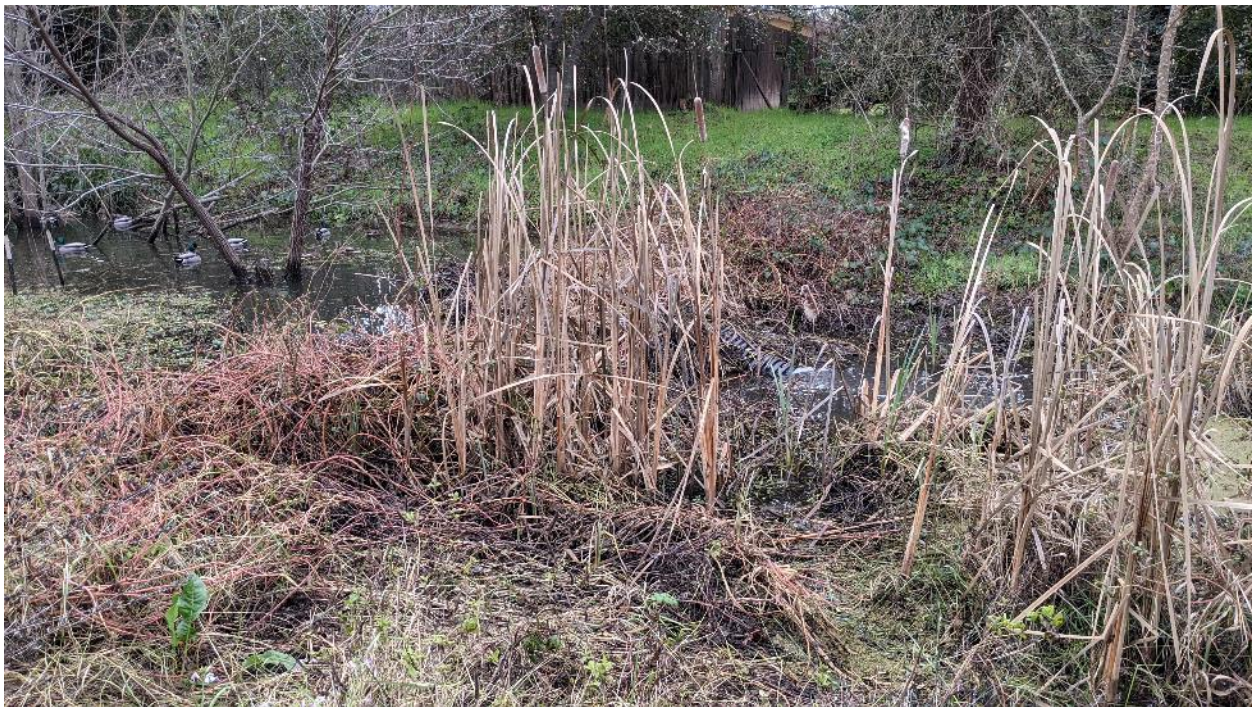
Figure 7b

Current Beaver Dam #2 with Flow Control Device (taken from right bank, flow from left to right)

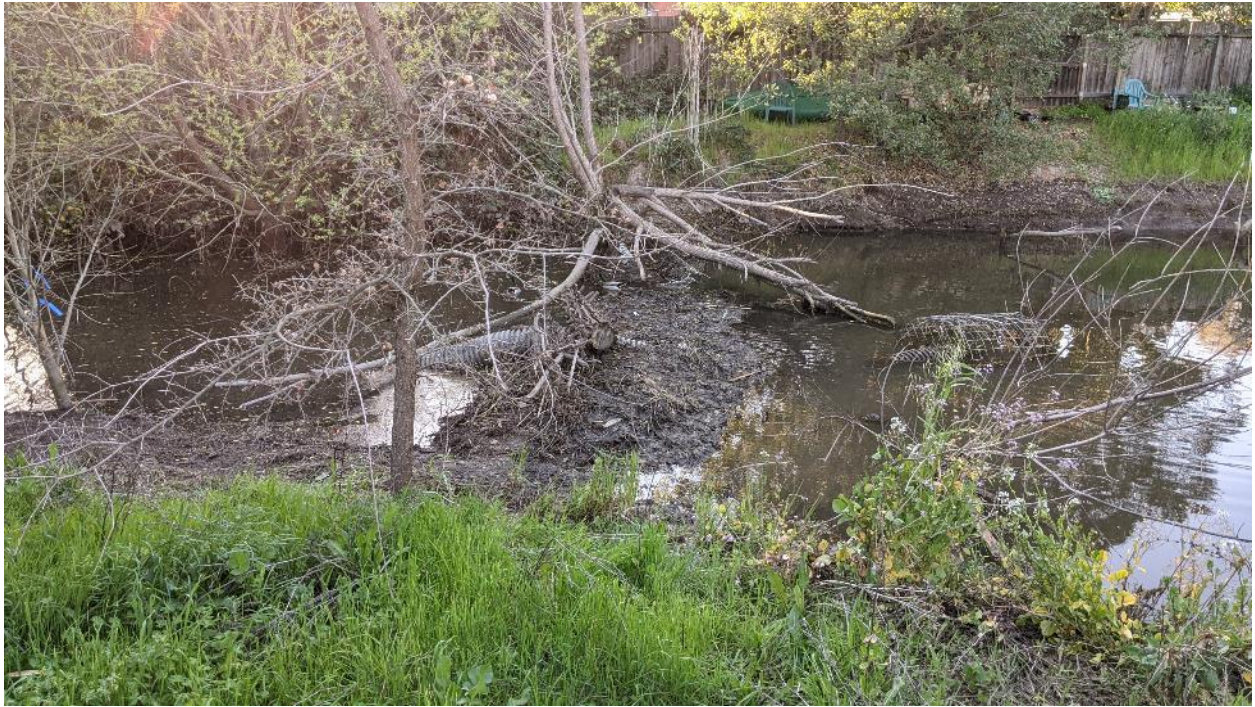
Figure 7c

Current Beaver Dam #3 with Flow Control Device (taken from left bank, flow from right to left)

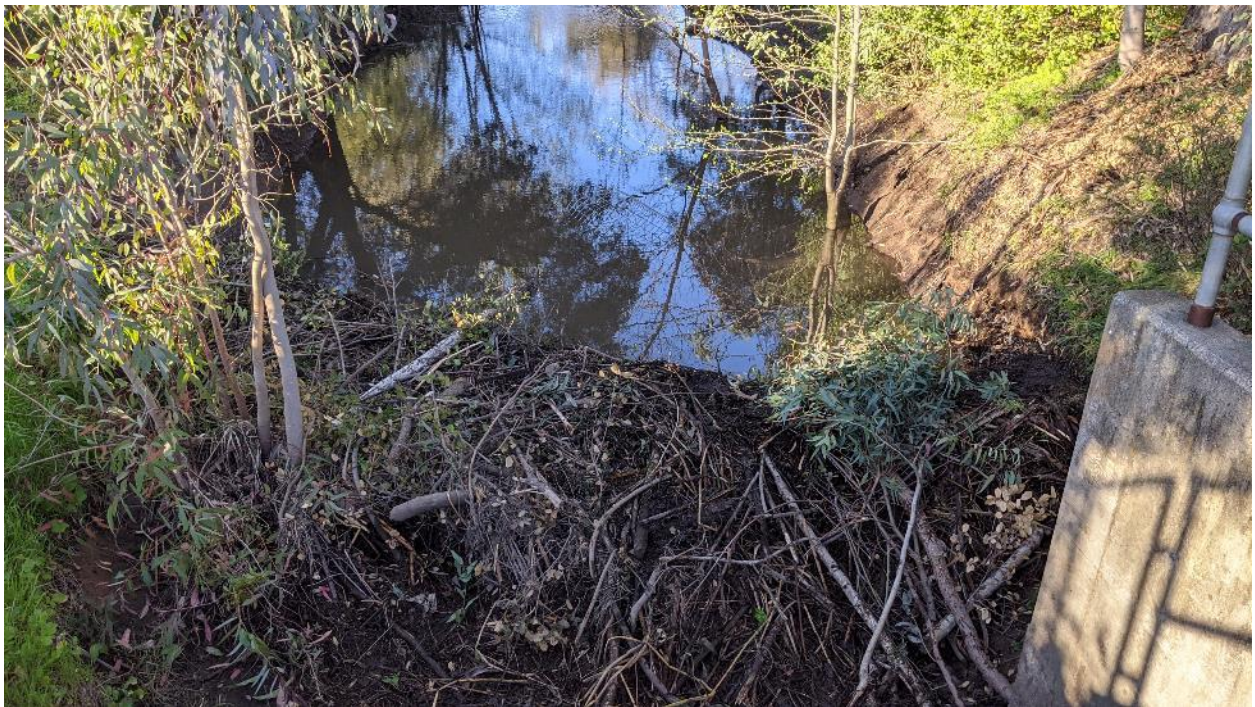
Figure 7d

Current Beaver Dam #4 with Flow Control Device (taken from W. MacArthur St. looking upstream)

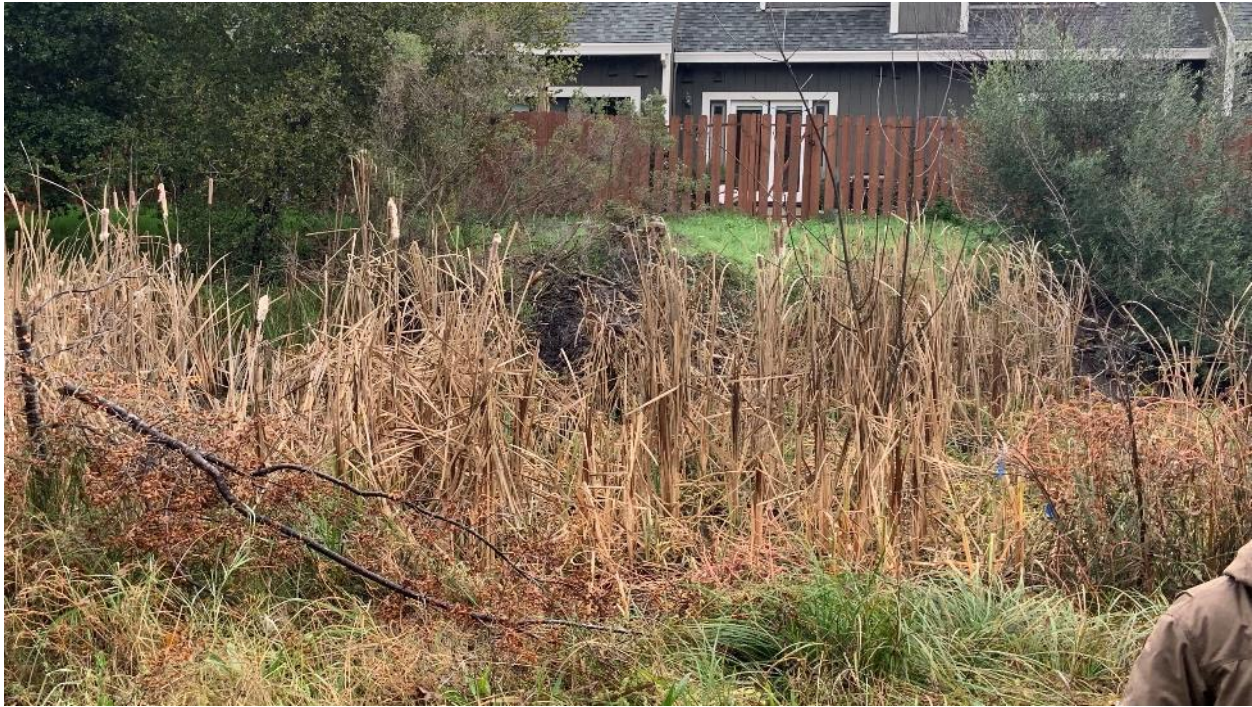
Figure 8a

Upstream of the beaver dams, wetland vegetation is established throughout the low flow channel, including cattails and bulrush (see Photo 8a above). The slower flow, and resulting fine sediment deposits, above the dams provide favorable conditions for these emergent wetland species.

Beaver Lodges on Left Bank (taken from right bank)

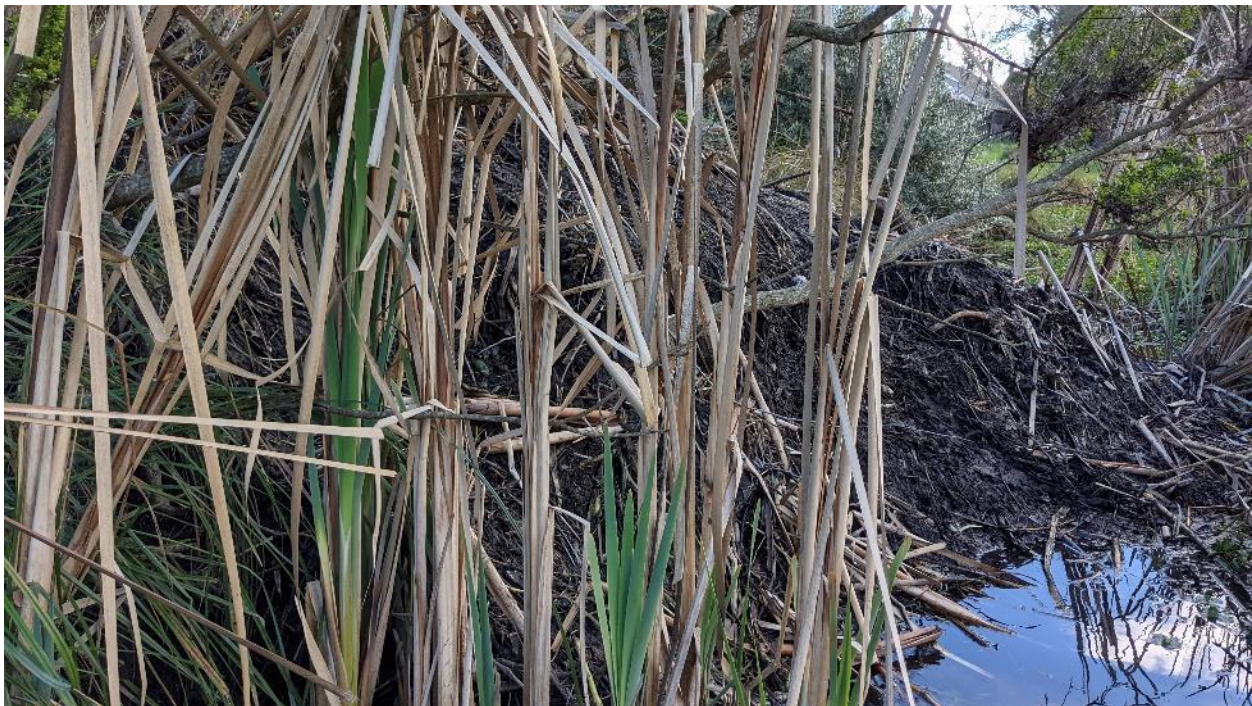
Figure 8b

Beaver Lodge Up-close (taken from left bank looking downstream)

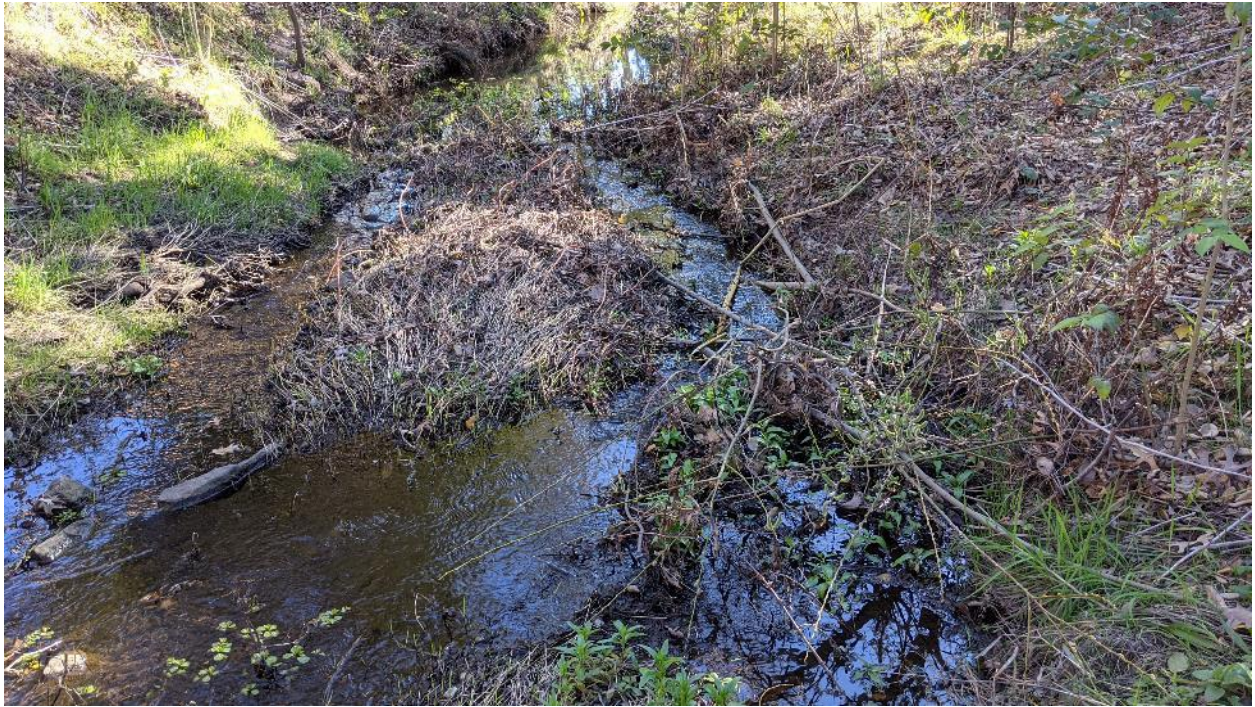
Figure 9a

Beaver Dam Activity Downstream of West MacArthur Street (taken from channel looking downstream)

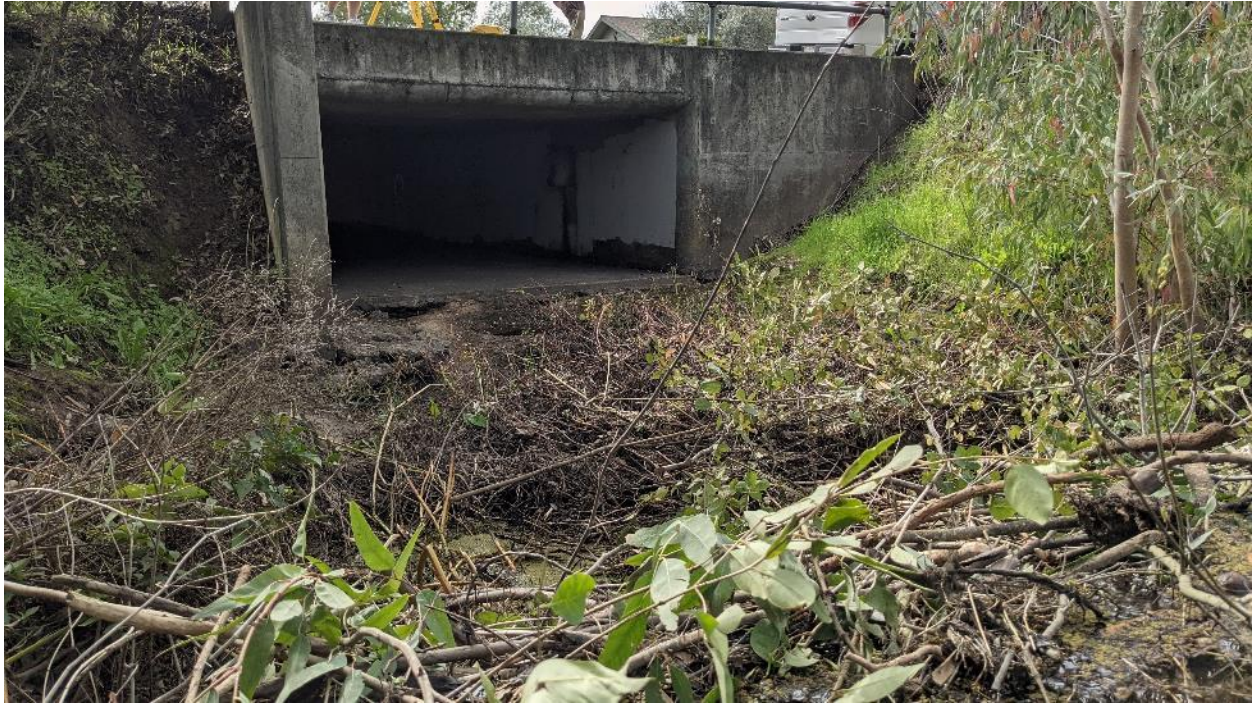
Figure 11a

Under the Without Dam condition, the West MacArthur Street culvert is controlling WSE upstream of the culvert. Modeling performed as part of the City of Sonoma Creek Storm Drain Master Plan (2011) shows overbank flow for the 25-year event upstream of the West MacArthur Street culvert (Figure 10). It’s clear this culvert is perched above the upstream and downstream channel profiles (Figure 11a-b, 12a-b). According to the City of Sonoma Creek Storm Drain Master Plan (2011), during the 25-year event the culvert creates a backwater effect that causes the WSE to exceed the channel banks upstream of West MacArthur Street. Modeled overbank flows then run through the development just to the east of Fryer Creek to end of the Project Area (Figure 10). The hydraulic modeling by PCI supports the results from the City of Sonoma Creek Storm Drain Master Plan (2011). Figure 10a and 10b show a 2.8, 2.5, and 2.5 feet rise across the West MacArthur Street culvert for the 2-, 25-, and 100-year flow events, respectively.

Upstream of West MacArthur Street Culvert looking Downstream

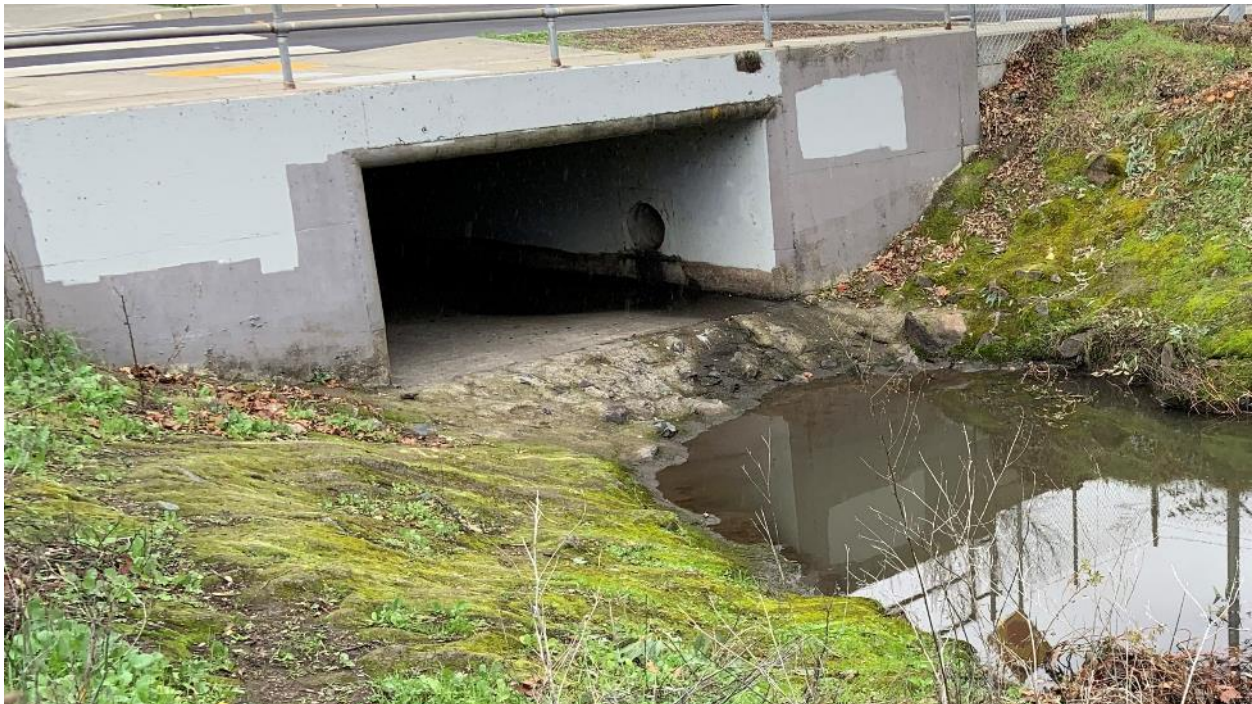
Figure 11b

Downstream of West MacArthur Street Culvert looking Upstream

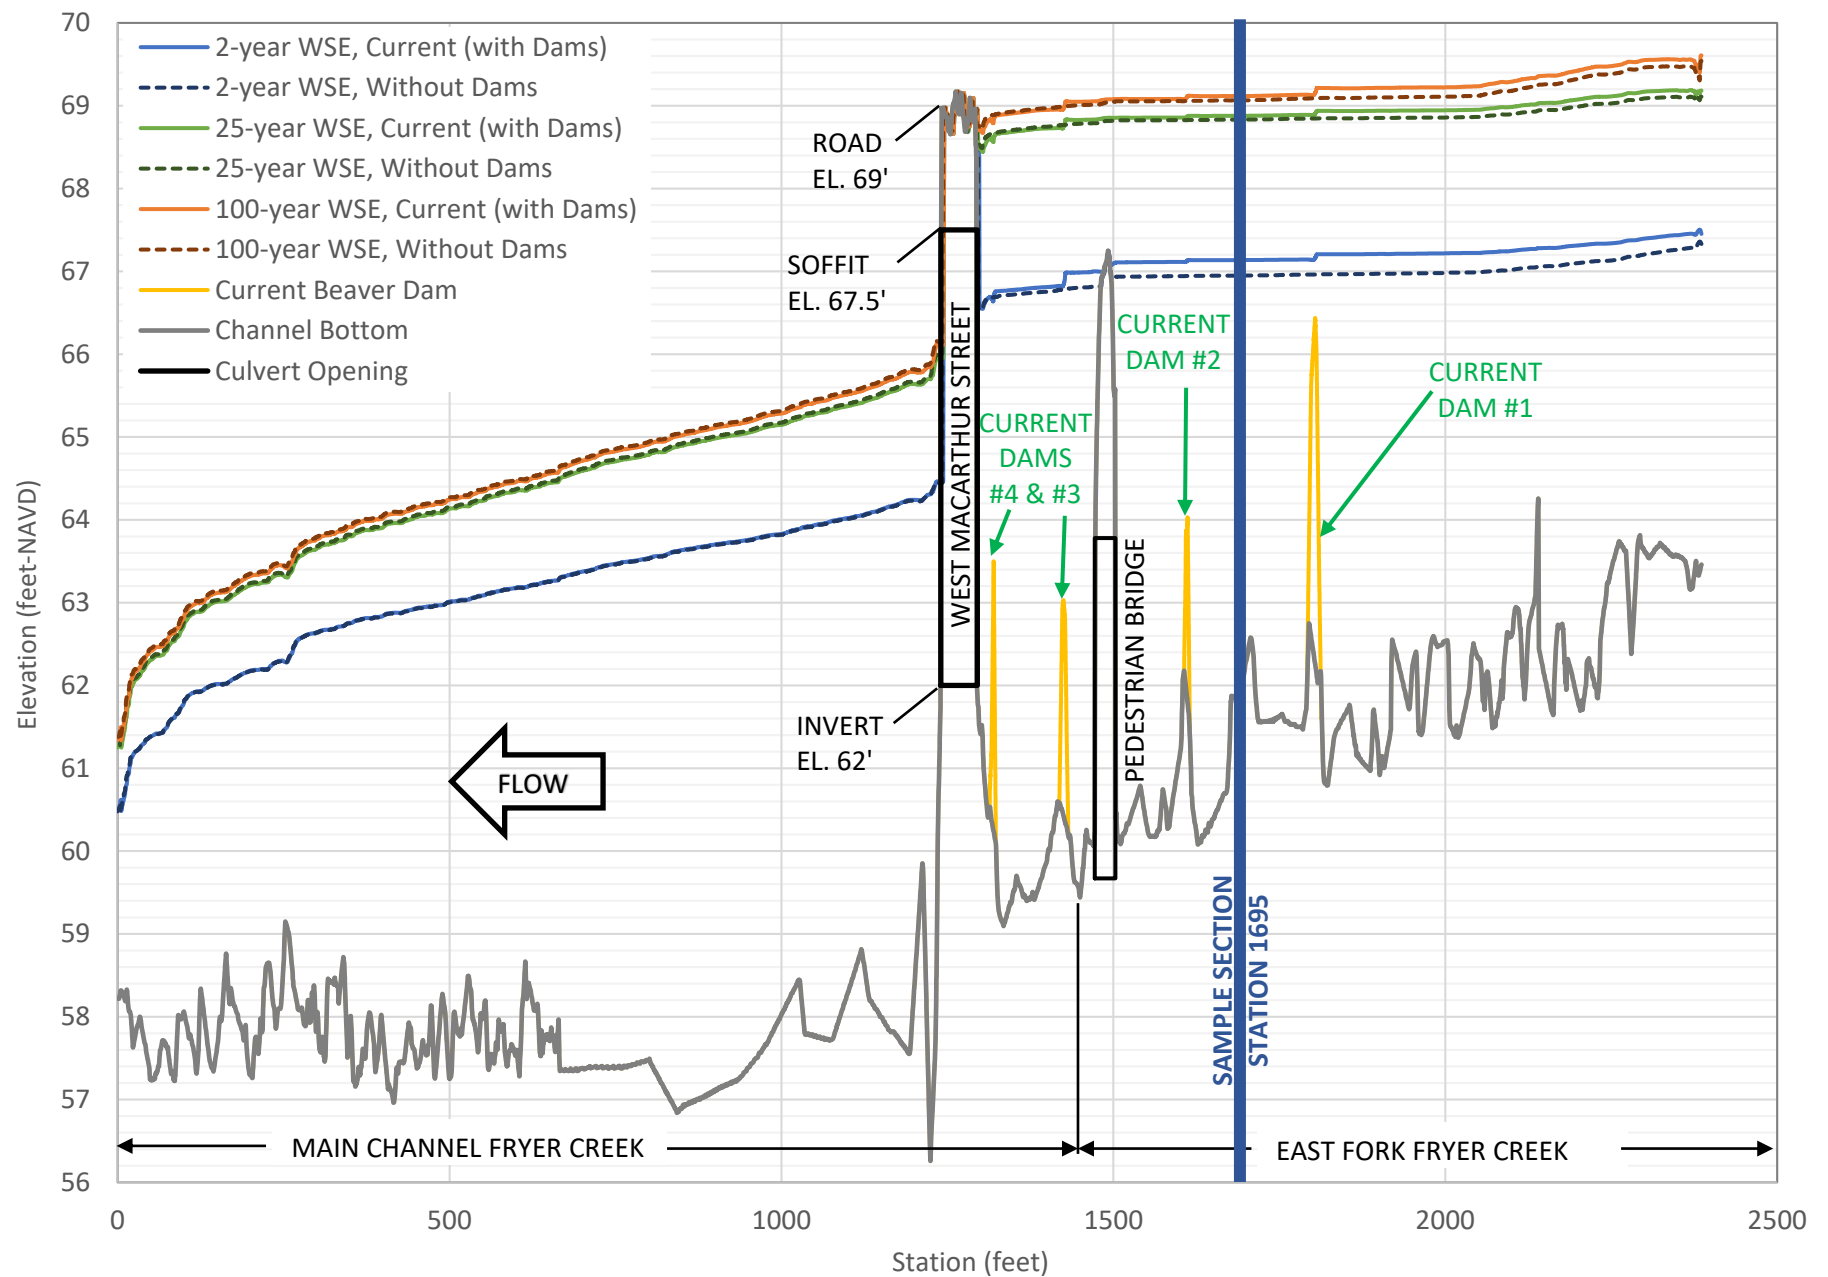
Figure 12a
Fryer Creek Beaver Impact Analysis and Alternatives Development
Without Dam and Current (with Dam) Model Water Surf. Prof. for M. Channel and E. Fork

As compared to the Without Dam scenario, the Current Dam condition creates a 0-0.2ft rise in the water surface profile across the Project Area for the 2-, 25-, and 100-year peak flow events. During the 25-year peak flow event, which is the design flow, the Current Dams cause a rise in WSE that is less than 0.1 feet at each dam, with the cumulative rise upstream of Current Dam #1 of less than 0.1 feet (**Figures 12a-b**). The same is true for the 100-year peak flow, with each dam causing a rise in WSE of less than 0.1 feet, and a cumulative rise of just slightly above 0.1 feet (**Figures 12a-b**). For the 2-year peak flow event, there is a rise of about 0.2 feet at Current Dam #3, which results in a cumulative effect of just above 0.2 feet upstream of Current Dam #1.

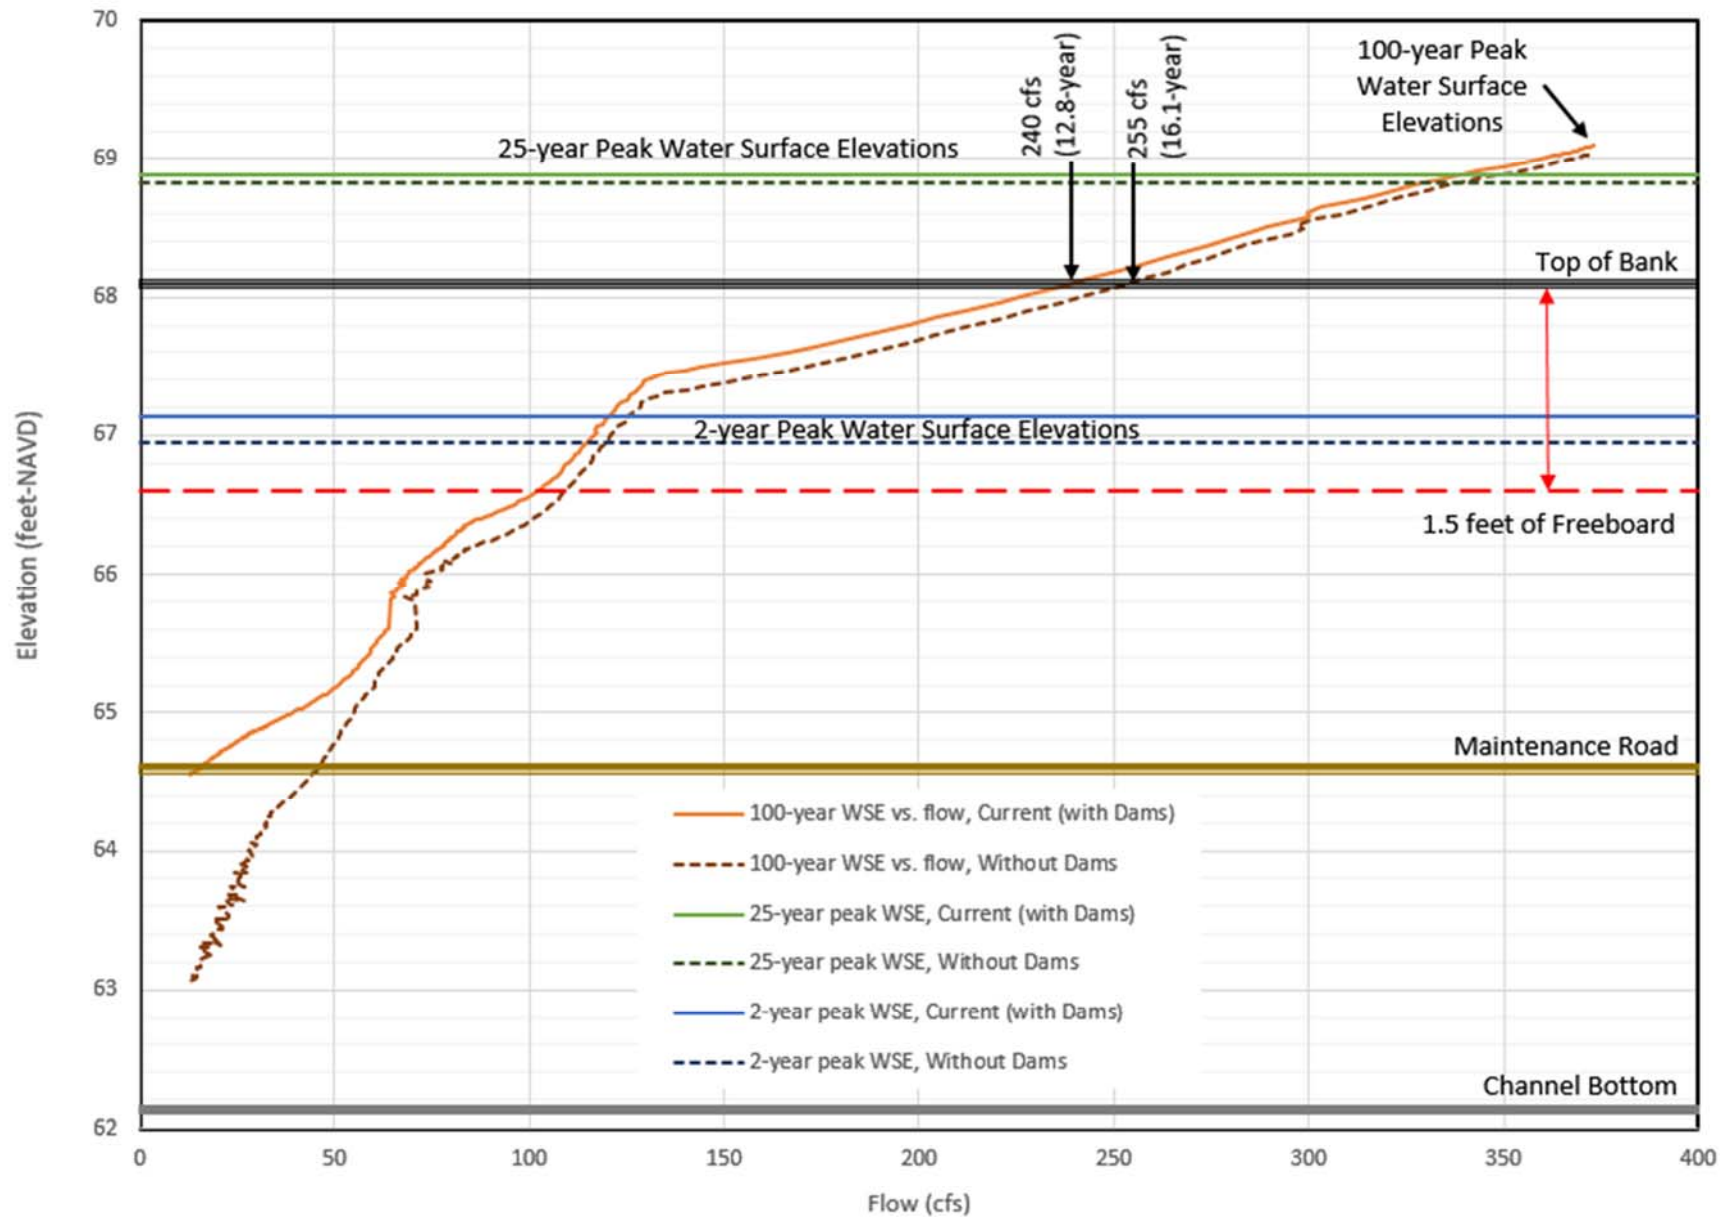
Figure 14
Fryer Creek Beaver Impact Analysis and Alternatives Development
Without Dams and Current (with Dams) Model Water Surf. Elev. vs. Flow at E. Fork Sta. 1695

During the lowest flow, 13 cfs, there is a large increase (approximately 1.5-feet) in water surface elevation (WSE) due to the Current Dams (#2-4) as compared to the Without Dam condition. At this flow, the Current Dam condition WSE is set by the downstream flow control device and is at the elevation of the maintenance road. However, the increase in WSE caused by the Current Dams diminishes rapidly to about 0.2 feet by 80 cfs. As stage approaches the top of bank, the difference in WSE between Current Dams and Without Dam condition is reduced to approximately 0.1 feet.

At the location where flows first begin to exit the channel, the Current Dam conditions result in approximately a 6% reduction of the channel's maximum flow capacity before flooding begins, as compared to the Without Dam condition. Under Current Dam conditions, the WSE exceeds the top of bank elevation at a slightly lower flow, 240 cfs (12.8-year peak flow event), versus 255 cfs (16.1-year peak flow event) for the Without Dam condition. Under either scenario, as a result of the backwater effect of the W. MacArthur St. culvert, flows are overtopping fairly frequently and not meeting the 25-year, 1.5 feet of freeboard or containment of the 100-year design criteria. This result is also reflected in the modelling performed for the SDMP.

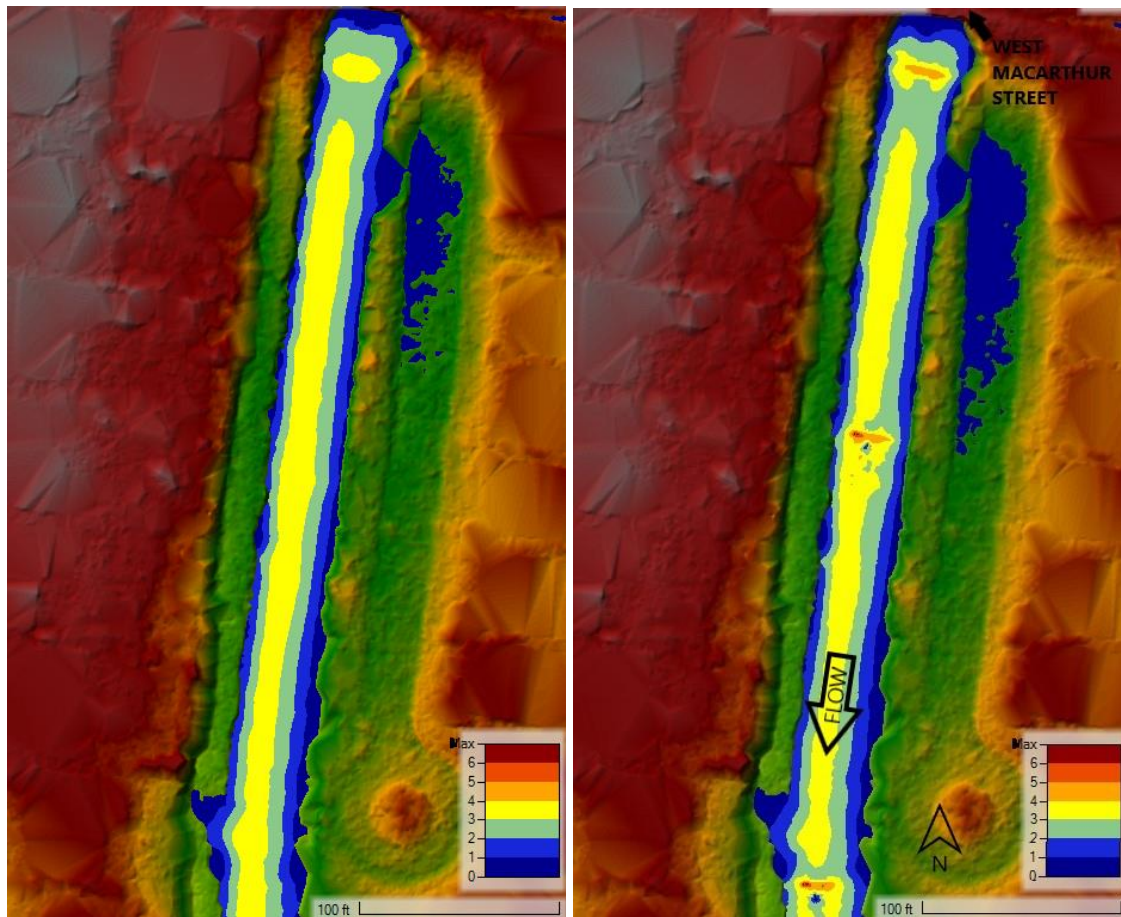
The model shows an increase in velocity across the dams to account for the discrepancy between bed heights versus WSE rise between the Future Dam condition to the Current Dam condition. Though the channel beds were raised by about 2-3 feet for the Future Dam condition, there is only about a 0-0.2 feet rise in WSE. In order to account for flow continuity, this means velocity must increase across the Future Dams. Spikes in velocity for Future Dam conditions at Future Dams #5-7 are shown in **Figure 17**. The increase in velocity at the Future Dams for the various modeled flows ranges between 1.5 and 2.7 feet/second (**Table 2**).

Current Conditions Future Conditions
Figure 17. Model Velocity Results for 25-year Peak Flow for Future Dams #5-7.

Given the rise in velocity across the Future Dams, it was worth examining whether the dams might be susceptible to failure during the peak flows modeled. Though very little information exists on the threshold for failure, the unit discharges at each dam were compared to the few reported values of 8-17 square feet per second by Westbrook et al. (2006), Levine and Meyers (2014), and Müller and Watling (2016). **Table 3** presents the unit discharges estimated for the Current Dams (#1-4) and Future Dams (#5-8). For the 2-year event, the Current Dam #4 and all Future Dams' (#5-8) unit discharges are within the reported range of failure. For the 25- and 100-year event, all Future Dams' (#5-8) unit discharges exceed the reported range of failure, while Current Dam #4 is within the range.

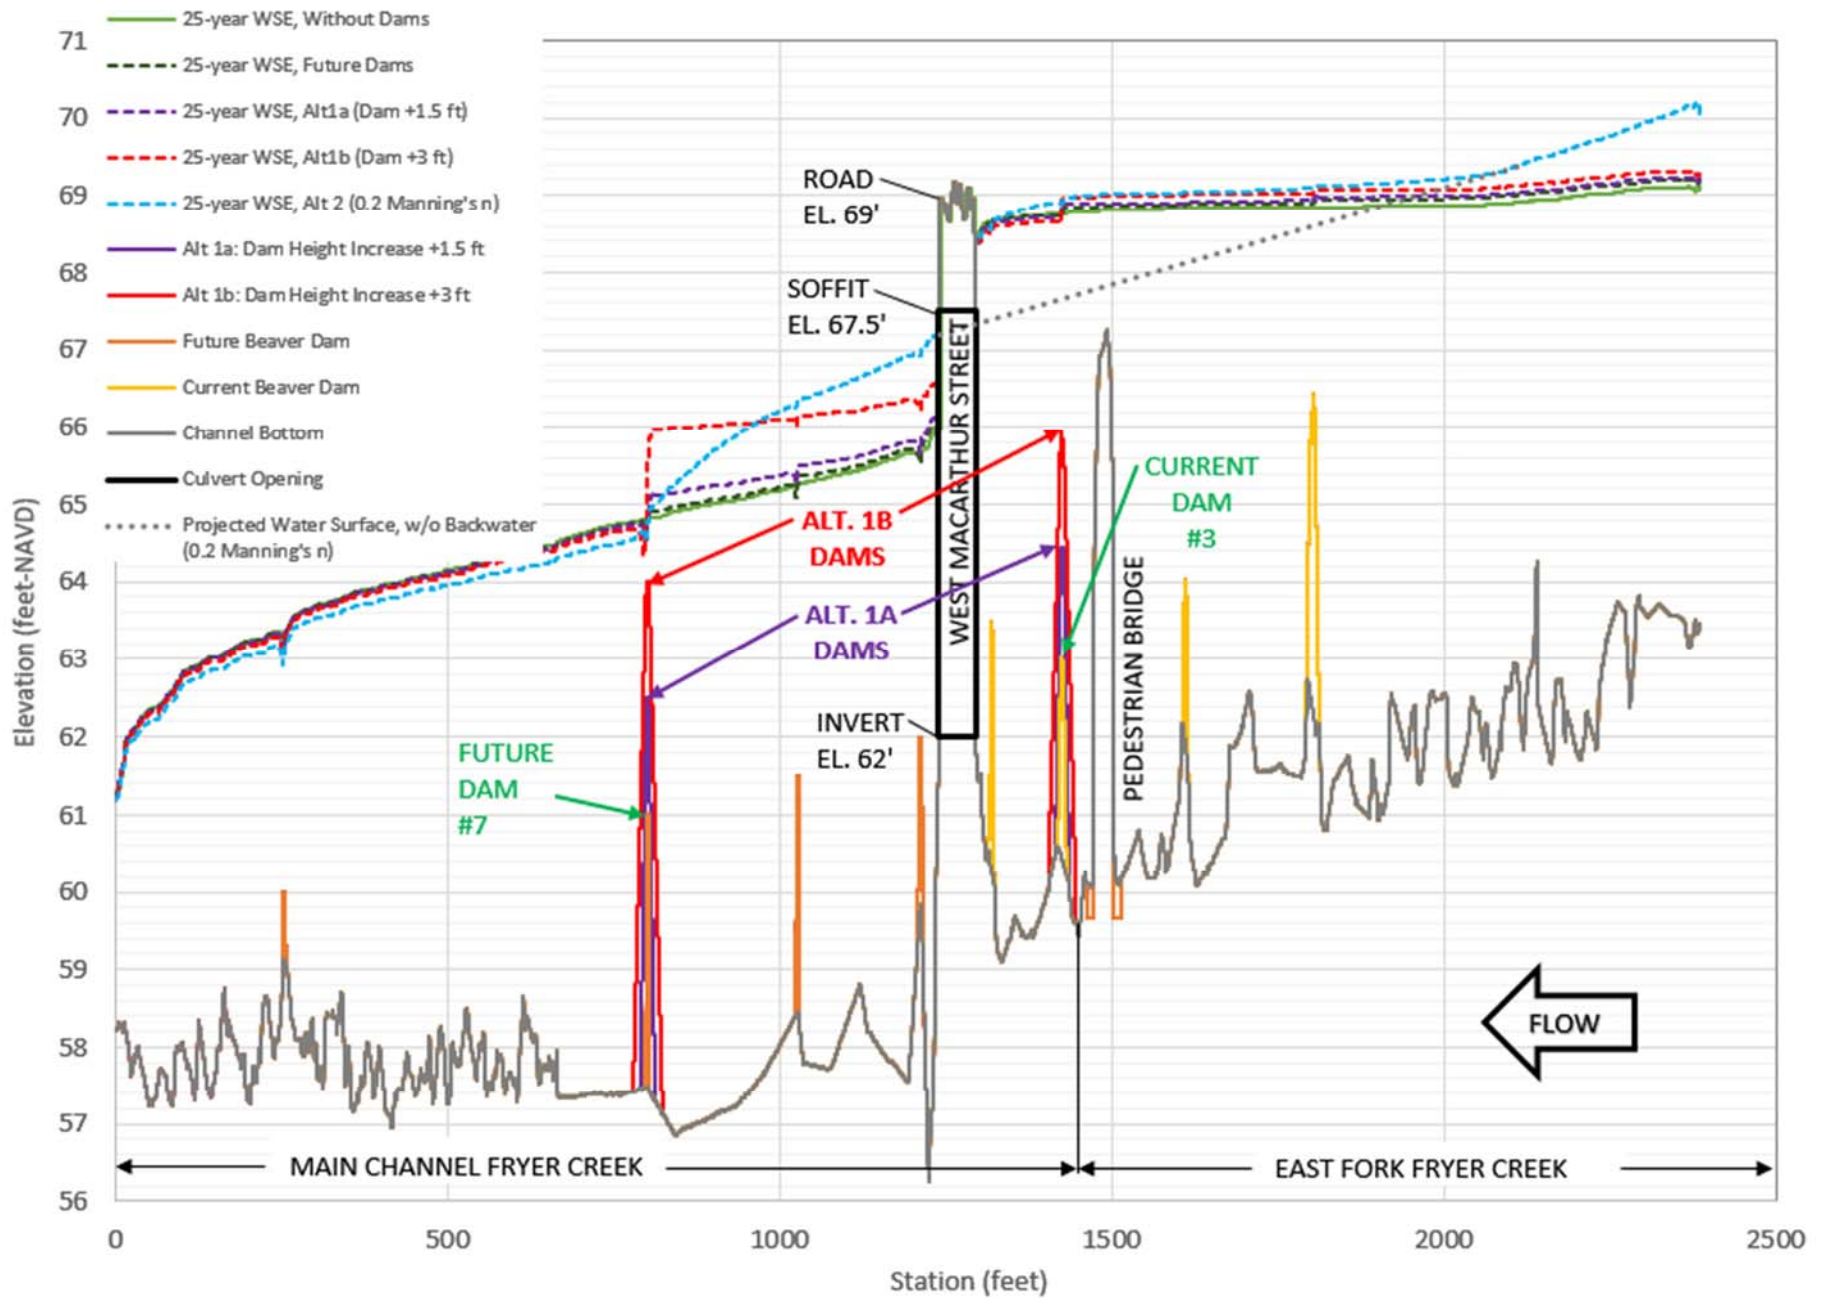
Figure 18
Fryer Creek Beaver Impact Analysis and Alternatives Development
Comparison of Dam Alternatives Water Surf. Prof. for M. Channel and E. Fork

Increasing the dam heights by 1.5 feet (Alt. 1a) caused an increase in WSE of about 0.1 feet from the “Without Dam” condition at Current Dam #3 and 0.3 feet at Future Dam #7. A 3-foot increase in dam height (Alt. 1b) resulted in an increase in WSE of about 0.2 feet at Current Dam #3 and 1.1 feet at Future Dam #7. By contrast, the “Future Dam” condition model which included both Current Dam #3 and Future Dam #7 at the original 3-foot height had only a 0.1-foot increase in WSE at each dam when compared to the “Without Dam” condition.

Ultimately, it’s only at the maximum expected beaver dam height outside the influence of other hydraulically controlling features that there appears to be a significant increase in the water surface profile. Upstream of the W. MacArthur St. culvert the hydraulic backwater effect drowns out even the maximum beaver height of 6 feet at Current Dam #3. In that location, flood conditions are much more controlled by the undersized crossing at MacArthur Street than they are by beaver dam conditions. However, downstream of W. MacArthur St., where the channel is confined and outside the effect of any hydraulic controls, an increase of 3 feet in dam height at Future Dam #7 creates a significant increase in WSE (1.1 feet) as compared to without dams.

The 25-year peak water surface profile for Alternative 2 is included in **Figure 18** to compare with the “Without Dam” and “Future Dam” condition as well as Alternatives 1a and 1b model results. The water surface profile for Alternative 2 shows the high roughness begins to elevate the water surface upstream of Future Dam #7 to a maximum of 1.1 feet above the “Without Dam” condition just downstream of W. MacArthur St. Immediately upstream of W. MacArthur St., once again the backwater effect of the culvert drowns out the influence of the high roughness. However, this influence appears to diminish approximately 750 feet upstream of the culvert, with the water surface once again elevating to

approximately 1.1 feet above the “Without Dam” condition at the very upstream end of the model. Interpolating from just downstream of W. MacArthur St. culvert upstream to the end of the model, it appears the effect of the high roughness would be about 1.1 feet across the reach if it were not for the backwater effect of the culvert (see grey dotted line, **Figure 18**).

The main management implication of the analysis of Alternatives 1a, 1b, and 2 for Sonoma Water is the possible need for increased monitoring and maintenance. The findings for Alternatives 1a and 1b suggest an increased need for monitoring to ensure new dams are identified early. Flow control devices should be monitored regularly, including after large storm events, to ensure that they are clear and in proper working order. In particular, inlet protection cages need to be inspected for potential damage or plugging after larger storms where bedload or vegetative debris have been transported by the stream. It appears there is some room for the dams to go undiscovered, but once the dams reach a typical maximum height of 6 feet they may prove to be problematic for meeting designed flood freeboard requirements. The analysis of Alternative 2 indicates the potential need to perform more regular vegetation clearing in the channel. Cattails are a source of food for beavers so some balance will need to be considered between vegetation clearing and maintaining resources for beavers.

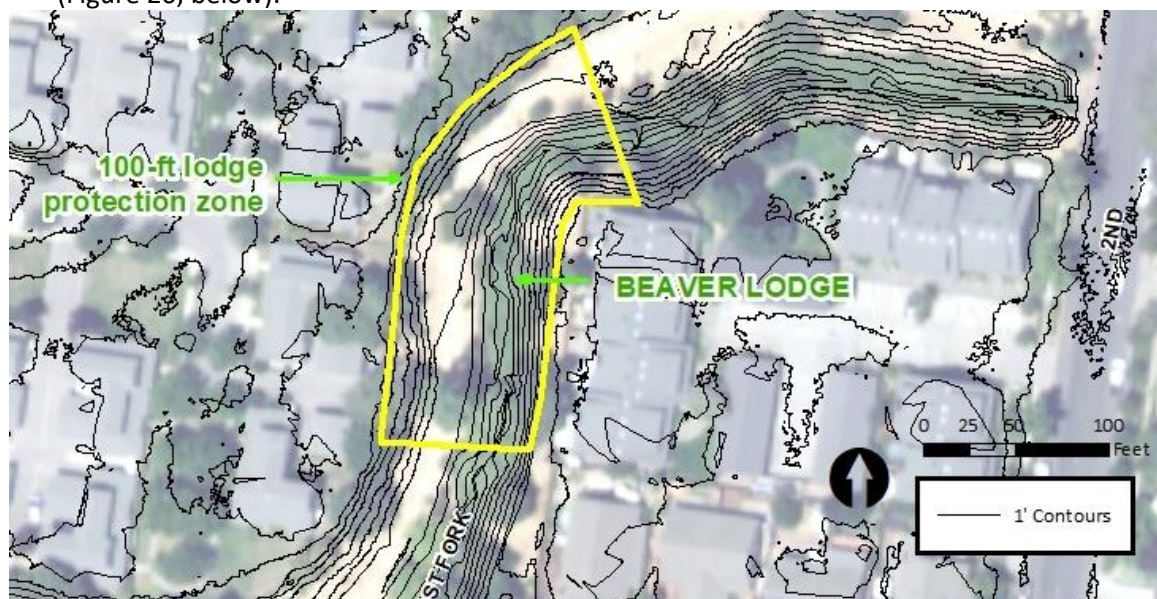
Figure 20. 100-foot zone around current Fryer Creek beaver lodge, for protection of beaver from stream maintenance activities

1. Designate the area within a 100-foot radius of the beaver's bank burrow (lodge) as "sensitive" (Figure 20, below).

2. Use landscaping flags on the banks to help work crews identify where this area begins and ends.
