Habitat Enhancement in The Salmon Creek Estuary

The purpose of the Salmon Creek Estuary Habitat Structures Project (Project) is to improve aquatic habitat in the lower Salmon Creek estuary (above photo) through installation of large wood structures and floating willow rafts. The instream habitat structures will provide refuge areas for salmonids and other aquatic species during high flows and cover from predation during low flow periods. Funds have been provided by the State Coastal Conservancy, California Department of Fish and Game (CDFG), Redwood Empire Chapter of Trout Unlimited (RETU), and The Nature Conservancy and NOAA Community-Based Restoration Program for permitting and design, transportation of project materials, construction, and monitoring.

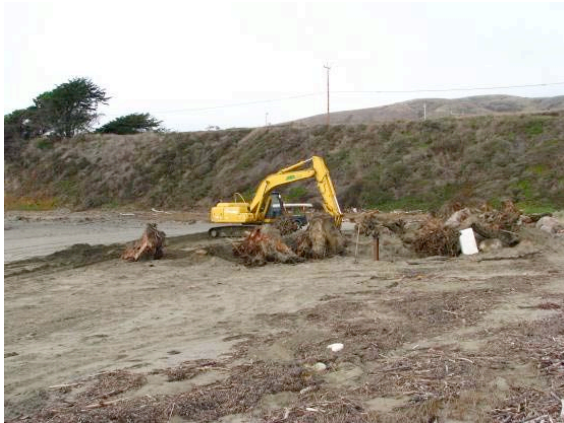
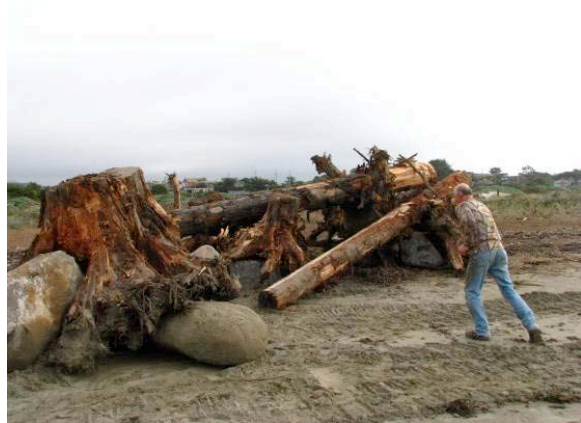
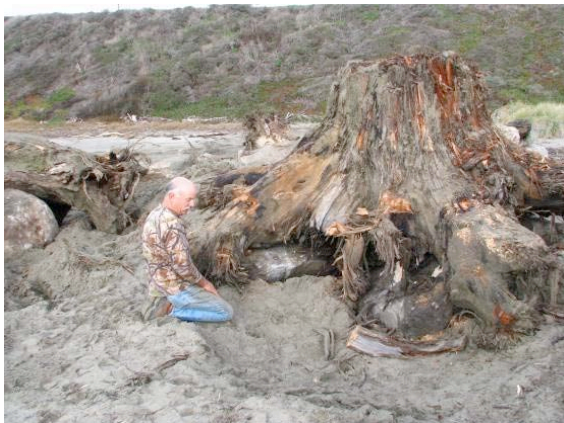
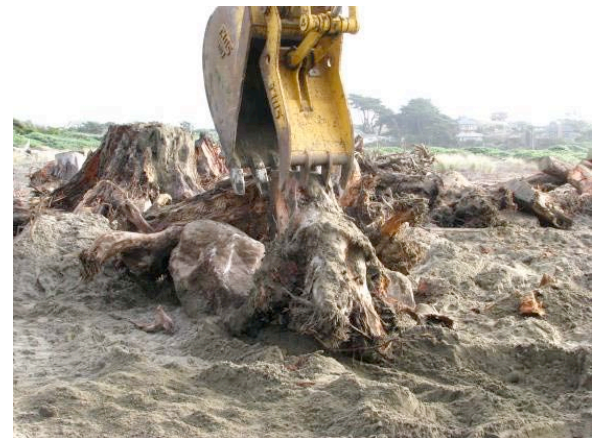
Twelve boulder/rootwad clusters were fabricated on the Salmon Creek staging area sandbar in early December 2010. These clusters consisted of 3-4 boulders (1-2 tons each) and 1-4 large redwood or fir rootwads cabled and pinned together (see photos below). The cluster dimensions ranged from 6'-14' in diameter and 4'-6' high.

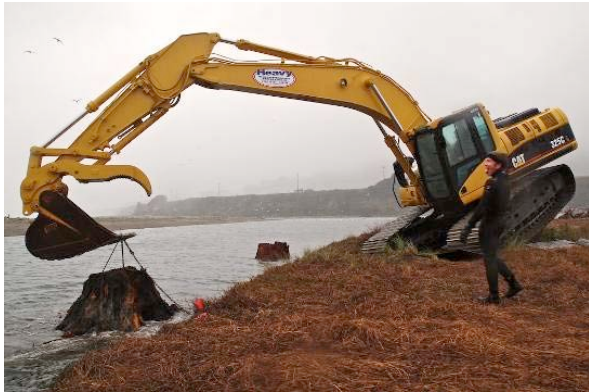
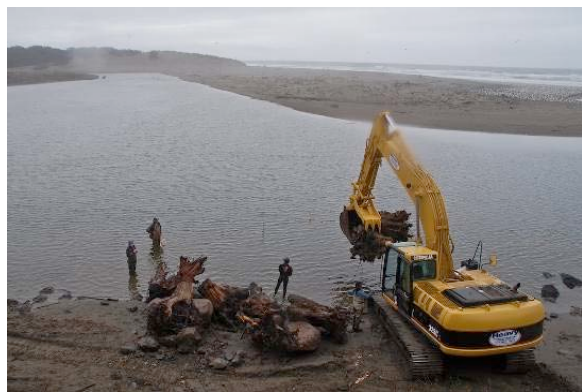
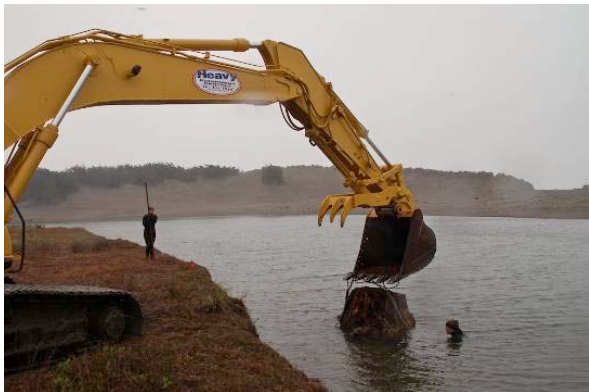
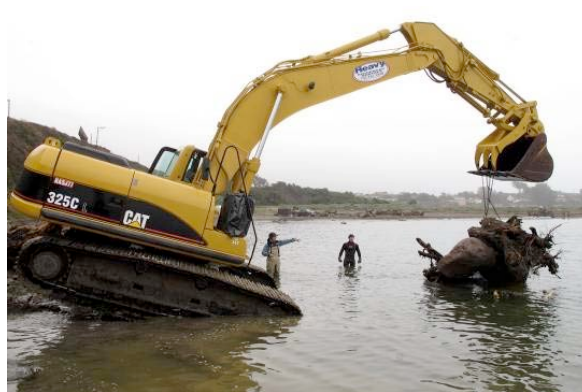
The structures were installed in the Salmon Creek estuary on February 14th and 15th, 2011. Several challenges arose in setting a date. There were conflicting needs to wait for ideal site conditions (low flows, open mouth, low estuary water surface, no rain) to be present and to reserve/schedule the equipment necessary for the install (only one excavator of size needed in the area). Mid-February had been tentatively scheduled for the install. As the day approached conditions in the estuary were changing daily. It was decided to go forward with February 14th, as the equipment was available, heavy rains were forecast for later in the week, and our NOAA-TNC project manager, Boze Hancock, was slated to be in town. Unfortunately, site conditions were not ideal. The estuary water level was high; forcing changes in structure placement locations. As planned, the four large, single-rootwad clusters were placed in the estuary

narrows and three complex clusters were placed near the mouth below the beach parking lot (see photos).

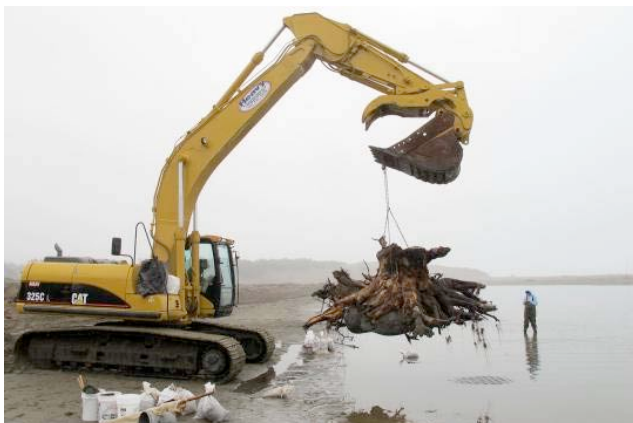
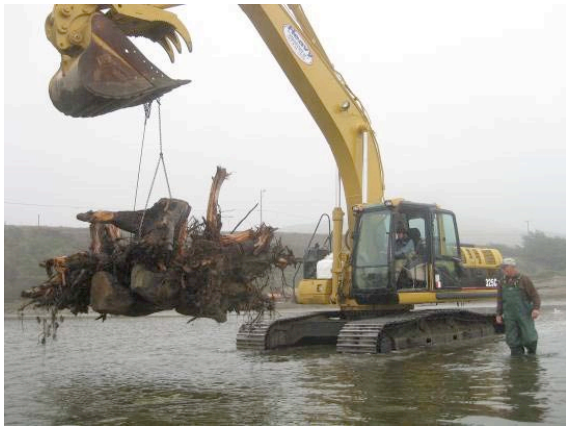
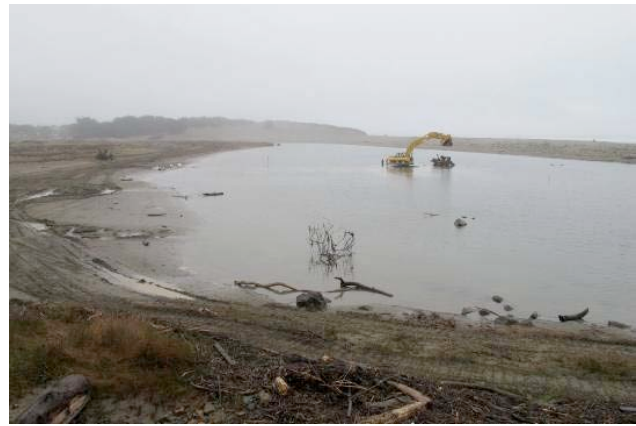
Then came the unknown – transporting structures 100 feet out into the middle of the estuary, across saturated sand, in water depths up to 2-3 feet. Rubber construction mats were tied together and laid out as a track in the water to the preferred placement site. A cluster was hooked up and the excavator was driven out on the mats. Slight settling occurred but nothing alarming. The rootwad cluster was set and the excavator backed up and out of the estuary (see photos below).

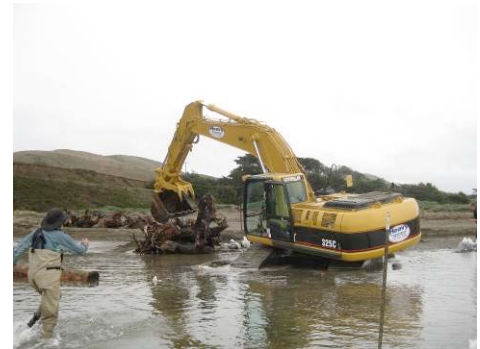
The final distribution of the clusters is 6 in the narrows reach, 1 in the center, and 5 near the mouth (Figure 2). All were placed in locations that historically have been the deep channel areas. After placing the clusters, several logs, some with boulders attached, were added to create more complexity and link clusters together. The use of logs was originally intended as a primary structure element, but upon placement it was concluded that they did not add significantly to the structure function as the placement angles were limited by access. Thus, only 3 logs were added.

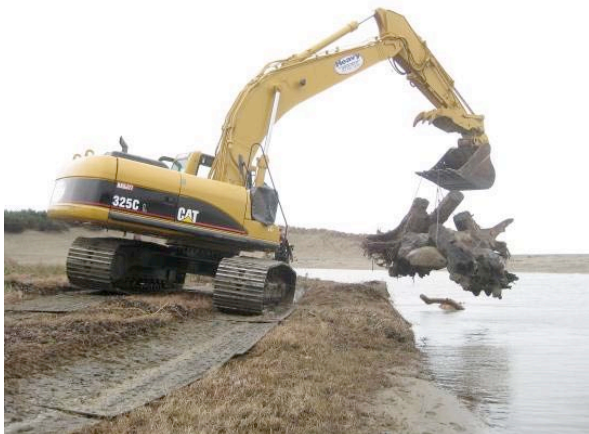
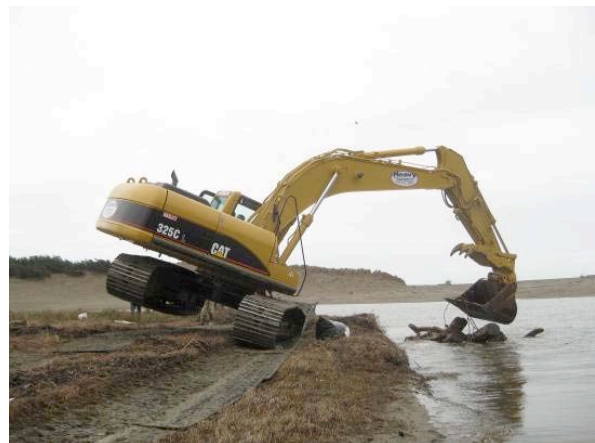
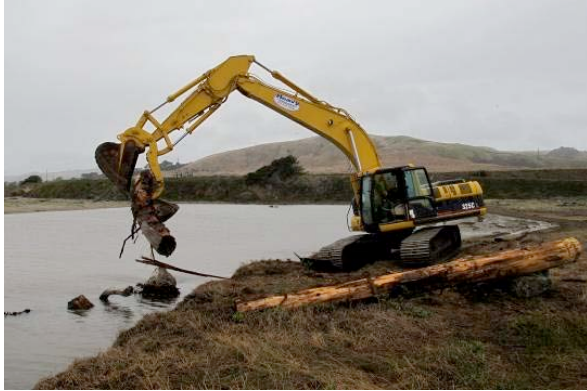
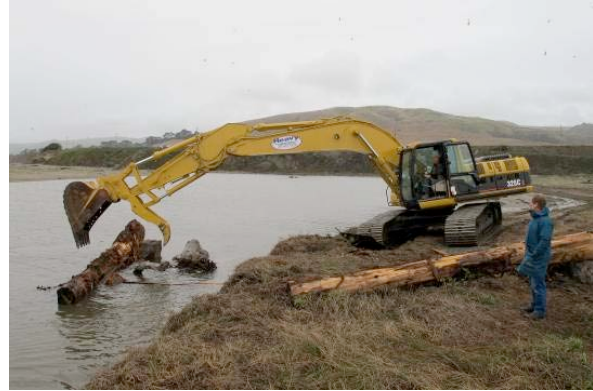
Photos by Brock Dolman

A large storm occurred the day after installation and the site has weathered many high flow events this spring. Baseline topographic surveys around the structures and as-built location mapping were completed after the initial storm event. The bolts and cables have been checked and tightened since installation. All remaining materials have been cleaned up and removed from the project area.

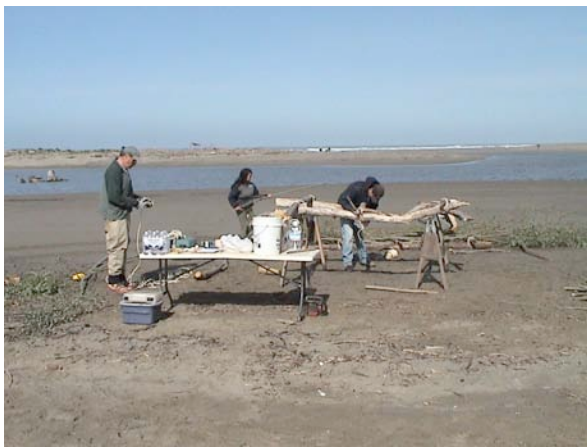
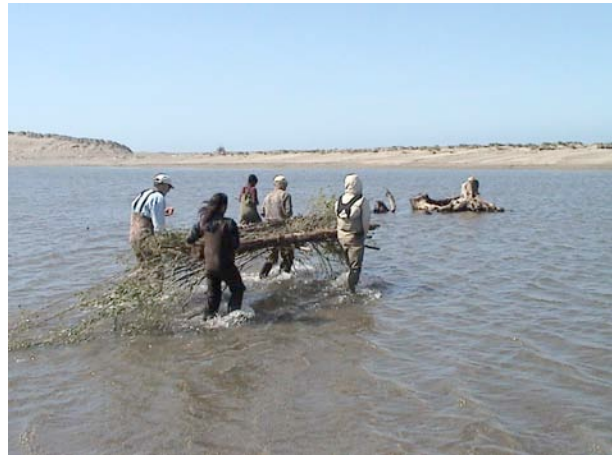
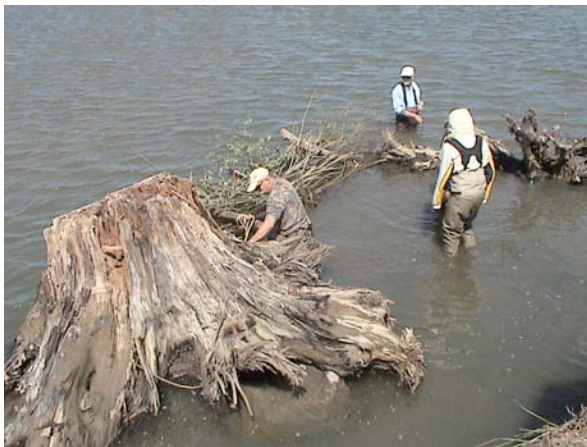
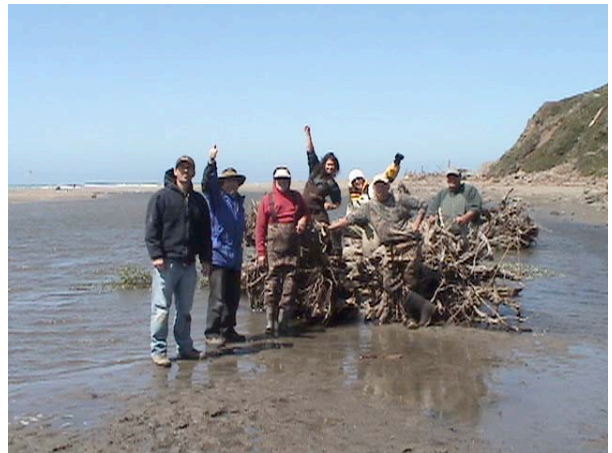
In April of 2011, Doug Gore of Dragon Fly Stream Enhancement led Redwood Empire Trout Unlimited (RETU) members, AmeriCorps and local watershed volunteers in constructing willow (*Salix spp.*) mat habitat structures in the Salmon Creek Estuary for the benefit of juvenile Coho Salmon and Steelhead. The willow mat structures were constructed on the beach, walked out to the Large Wood Structures described above, and secured using hemp twine. See photos below illustrating the procedure. The project biologist was on hand to make sure no salmonids or tidewater goby were harmed in the process.

For the most part the mats stayed in place through the summer, even after withstanding several late spring/early summer storms and high flows.

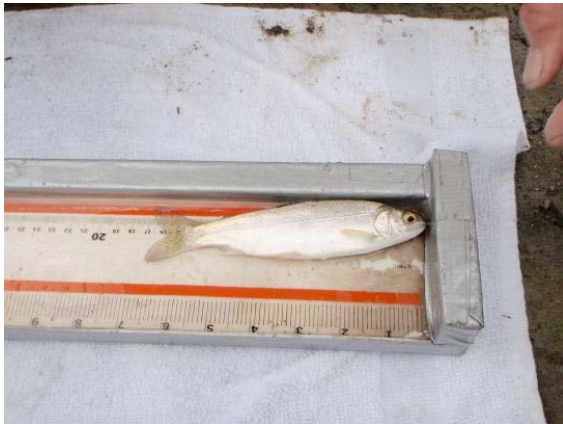
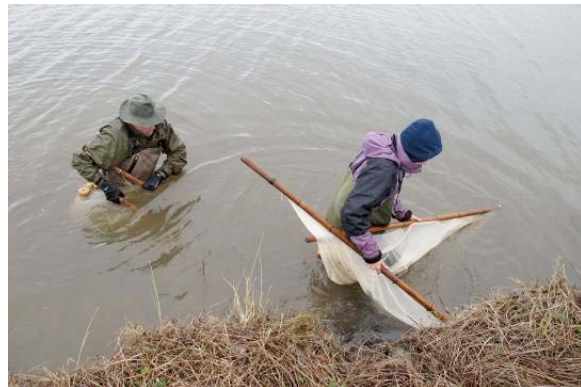
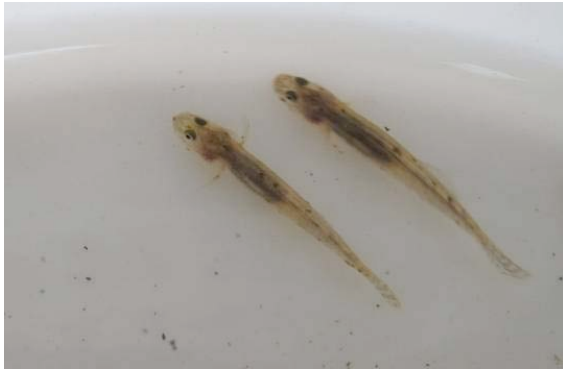
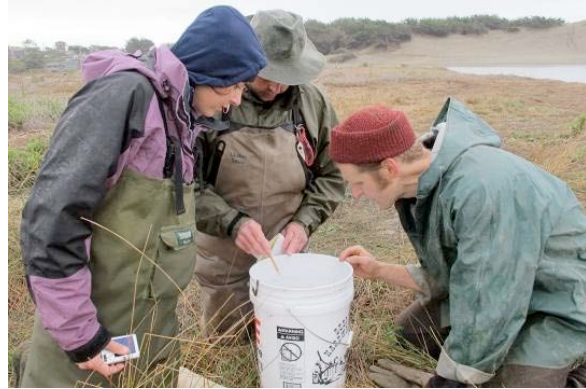
Construction biological monitoring was conducted during installation activities. Hand seining and snorkeling by agency-approved biologists occurred at each structure site immediately prior to installation. No fish were collected in the open estuary during the installation process. However, sampling of the overhanging banks in the narrows netted 17 tidewater gobies. This was the first time many of us have seen this endangered species that caused project delays. See photos below.

Upper left photo of juvenile steelhead smolt by Jennifer Michaud. Top right and bottom two photos, including tidewater goby in lower left, by Brock Dolman.

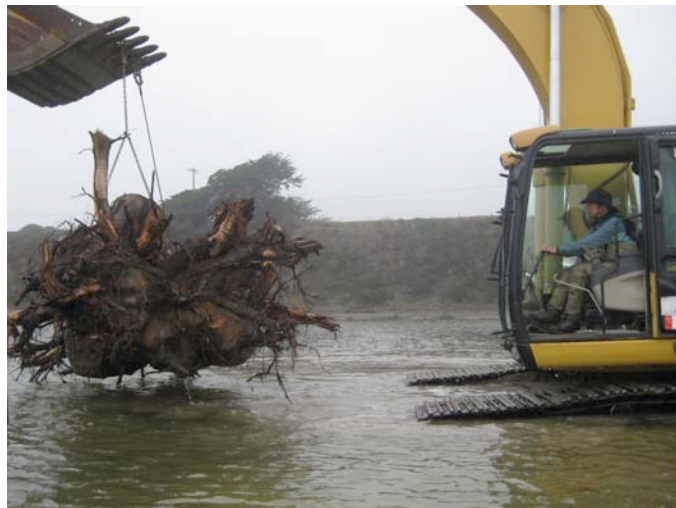
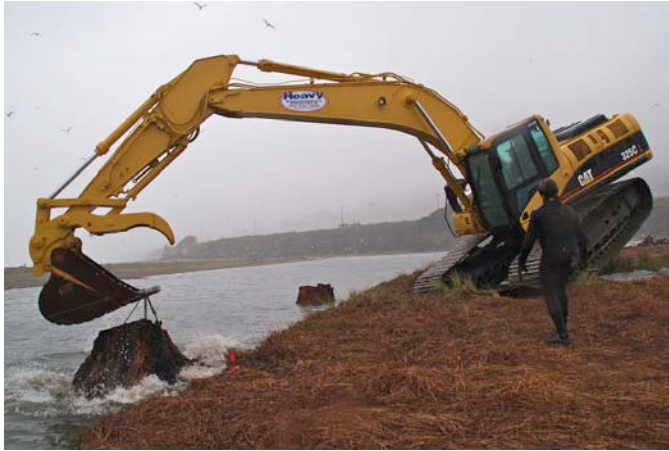
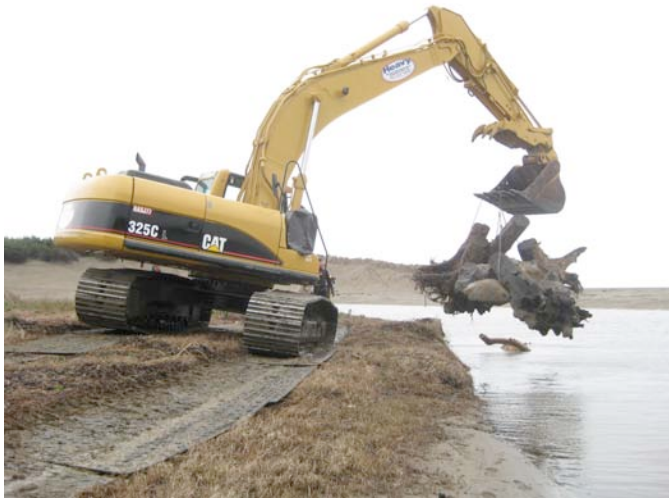
Unlike wood structures installed along channel margins in upland creeks, estuary structures cannot be anchored to secure trees along the bank or buried in floodplain banks. Thus, they must be attached to boulders or, perhaps, cabled and anchored deep into the bed sediments. The wood's buoyancy and the pressure forces of the flood flows must be overcome if the

structures are to remain in place. If not sufficiently weighted there is risk that the wood will float downstream out of the estuary or be rafted to shore. For example, each 6 foot diameter rootwad required 4 to 6 tons of rock for stability. Also, unlike wood installation in creeks, the estuary cannot easily be dewatered, and thus the boulders need to be attached to the wood prior to installation and moved as a unit into place. The weight of the wood and boulder complexes quickly overwhelms the capabilities of widely available heavy equipment.
