Indications of Beaver and Identification of Remnant Beaver Dams in Tásmam Koyóm

Sabra Purdy, M.S. Aquatic Restoration Ecologist, April 30, 2020

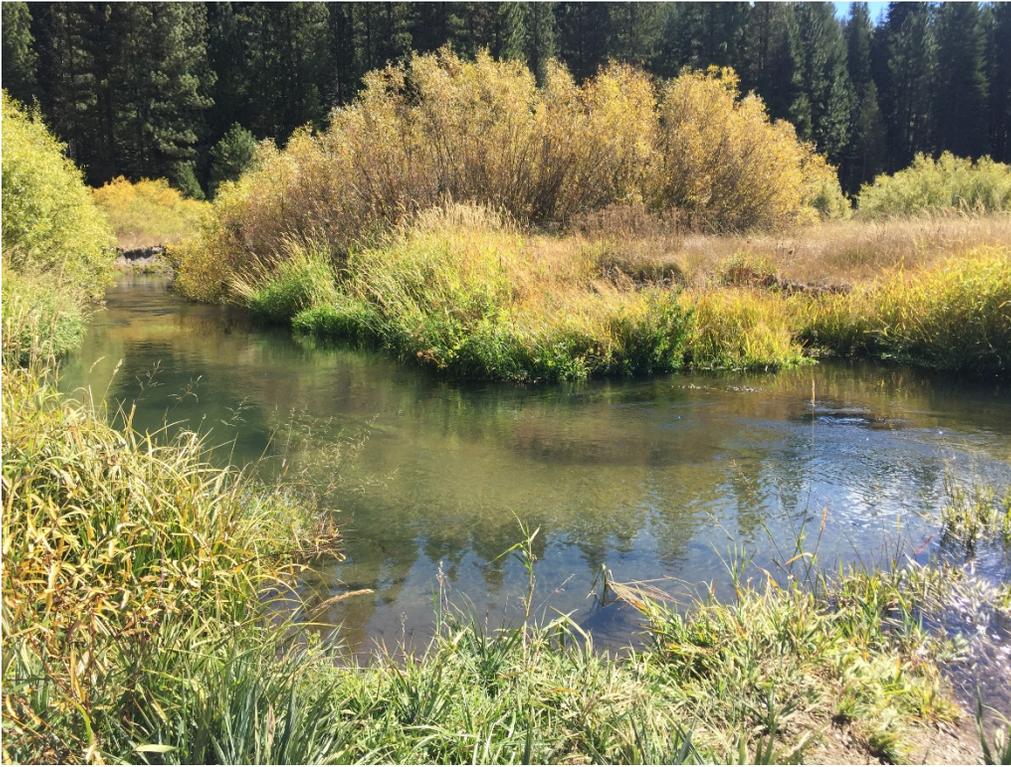
Figure 1. Just downstream from the location where the Beaver Dam remnant sample was taken. The bulging trapezoidal shaped bank on both sides of the channel indicates a buried remnant beaver dam. Beneath the sod and sedges, there are obvious remnant sticks visible under the waterline in the channel.

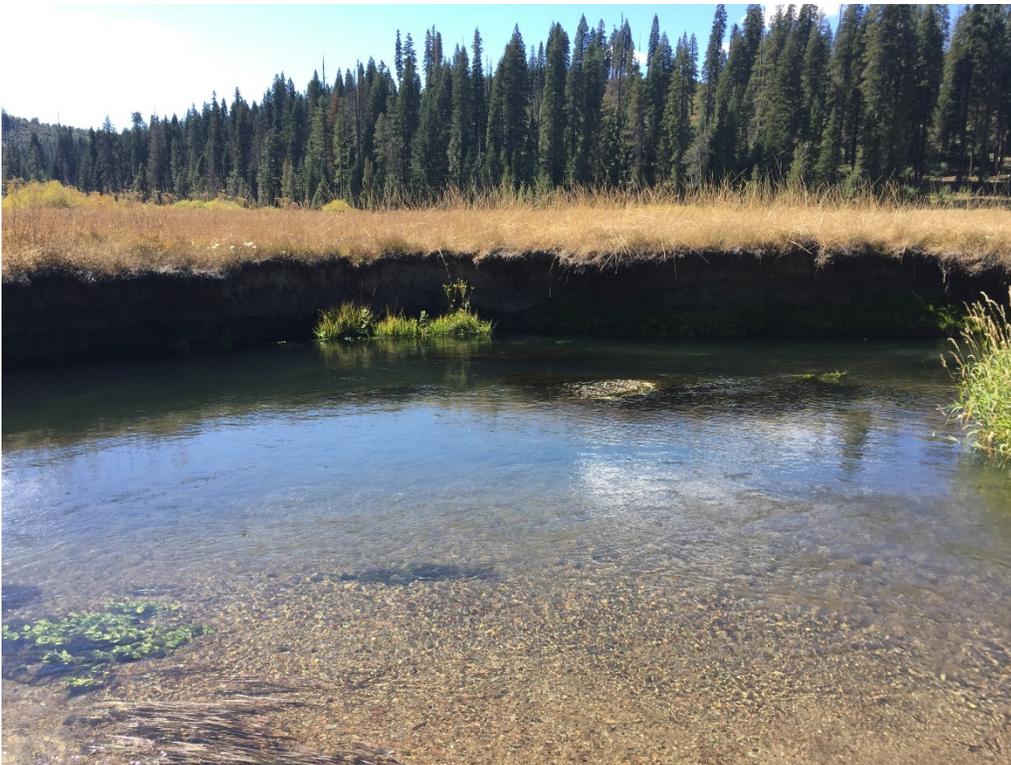
Figure 2. The remnant sample was taken from the cutbank pictured here near the small sod chunk across the stream channel. There are numerous other indicators of the earlier presence of beaver dams here including sod islands, and the remnants of the emergent marsh habitat created by the dam on river left.

We chose an obvious dam remnant that had the telltale beaver dam shape emerging from the river right side of the channel in reach TK-1 channel unit FNRN6. The remnant was approximately 0.4 m below the surface of the water and about 0.45 m tall and 0.5 m wide at the base. The size and arrangement of the sticks were very typical of beaver dams in the Sierra Nevada with most of the wood ranging in size from about 0.5cm to 3 cm diameter. Since the sticks in the remnant are subject to the stream flows at all levels, they are frequently broken off and do not show distinct beaver sign, but if one were to excavate farther into the bank, it might be possible to recover a stick with more obvious beaver sign, but it is not unusual for remnant beaver dams to have the beaver sign broken off in high flows. There were numerous indications of beaver dams at this channel unit including several islands, trapezoidal shaped remnants covered in sod at the stream margins, and bank shape and vegetation patterns consistent with the earlier presence of a dam. We felt confident that our choice of wood to sample was definitely the remnants of a beaver dam. I had no expectations that the site would yield beaver dam remnants of such ancient pedigree. My hypothesis was that we would not get conclusive evidence of pre-settlement or pre-reintroduction beaver presence. I was extremely pleased and surprised when the results of the carbon dating were unequivocally of such ancient pedigree. However, all scientific endeavors need replication and multiple data points. This single sample is an excellent piece of novel physical evidence of pre-settlement beaver inhabitation at this site. However, it would be best to collect and run additional samples of remnant beaver dams throughout the site to get definitive proof and have more statistically significant data in order to unequivocally prove the historical presence of beaver at this site.

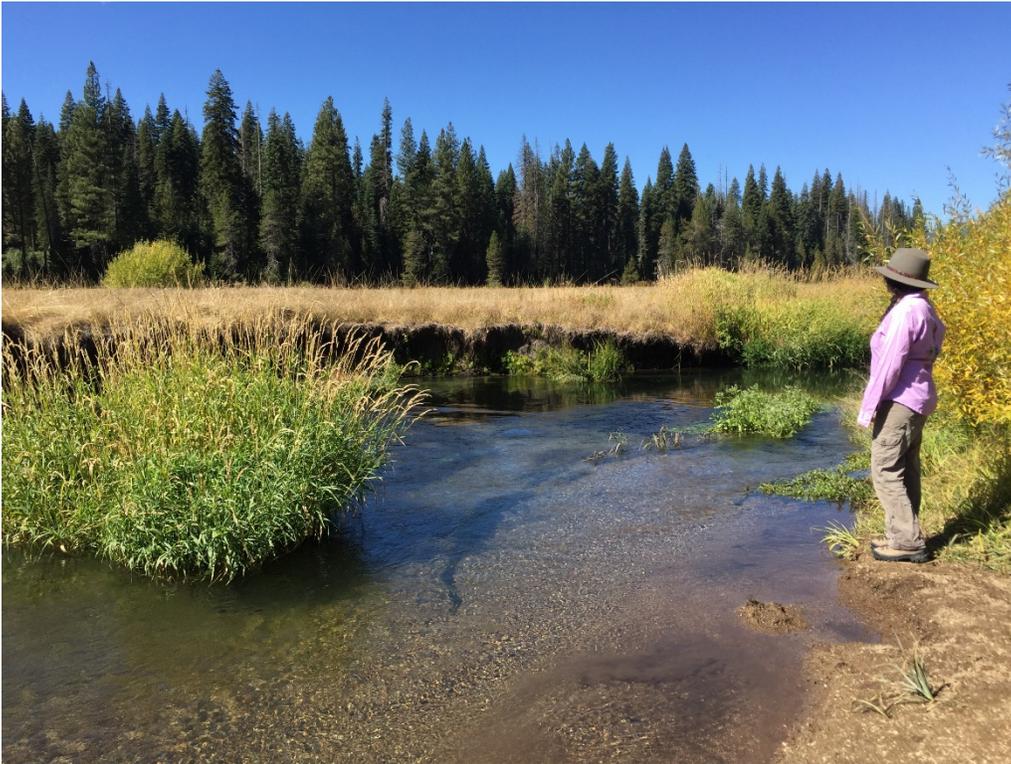
Figure 3. Remnant chunk of beaver dam with sediments accreted on top allowing for grass to colonize. The area where the person in the photo is standing was the emergent marsh habitat created by former beaver dams at this site in Tásmam Koyóm.

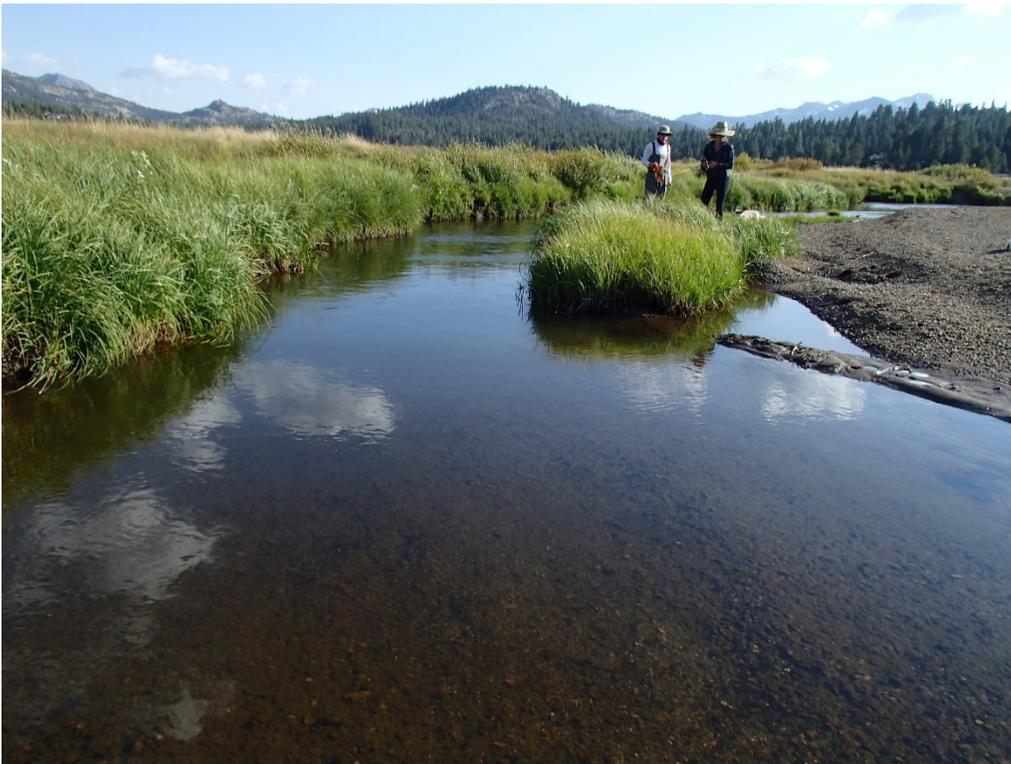
Figure 4. Typical "Beaver shaped banks" in Hope Valley, CA, 2017. The shape and vegetation cover are very typical of the area upstream of a beaver dam that remained in place for several seasons allowing sediment deposition upstream of the dam and stabilization of banks due to a higher water table and reduced stream velocity. This distinctive bank shape can persist long after the beaver dam that created them has washed out. A partial dam remnant can be seen in this photo mid-channel with telltale beaver sign sticks at the base.

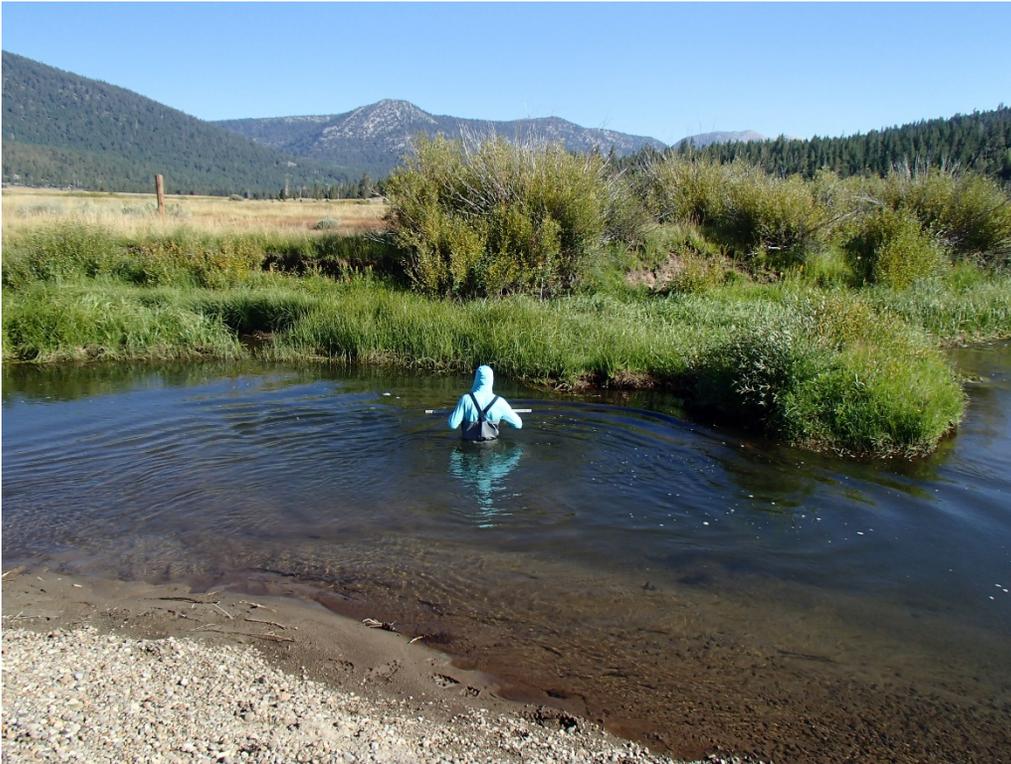
Figure 5. A remnant dam along the channel. Note the distinctive wedge shape created by the dam itself and the fine sediments leading to emergent marsh habitat on both the downstream and upstream side of the dam. When dams are partially breached like this one, they often create a scour pool where the dam once was. This geomorphic evolution can be observed consistently throughout Sierran Meadows and the landform is very distinctive. Hope Valley, 2017.

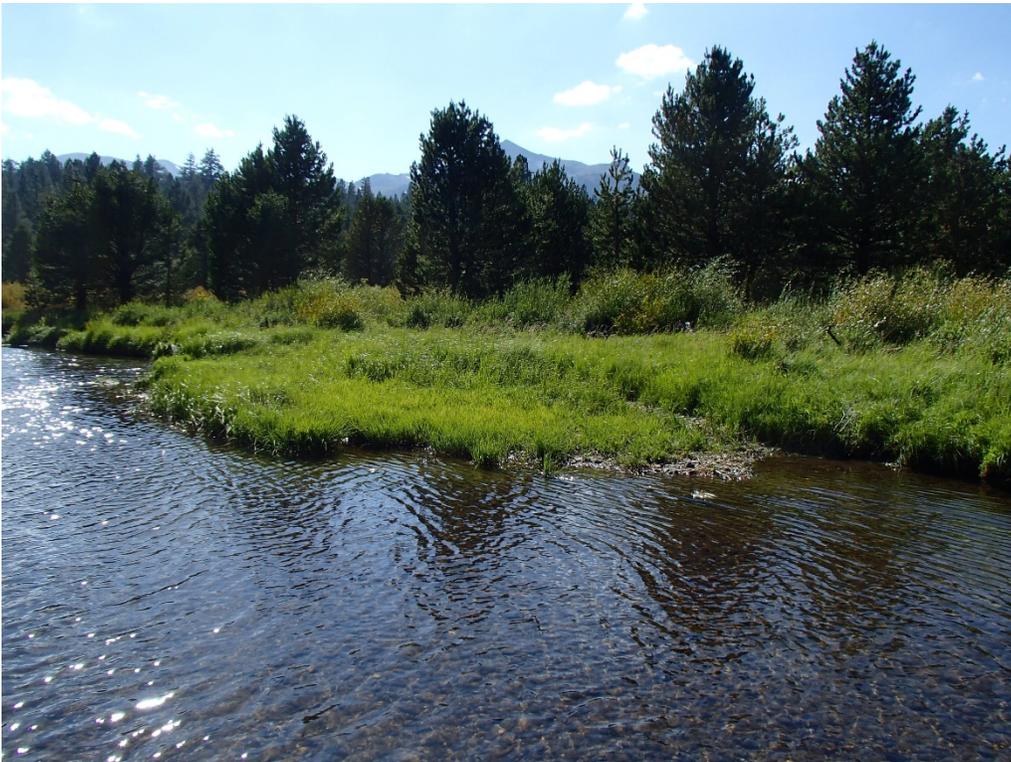
Figure 6. The beaver dam here is long gone but the inset floodplain development that occurred due to presence of the dam generating emergent marsh habitat persists and indicates the earlier presence of the dam. Dam remnants at the channel margins confirm the presence of an earlier beaver dam. Photo from Hope Valley 2017.

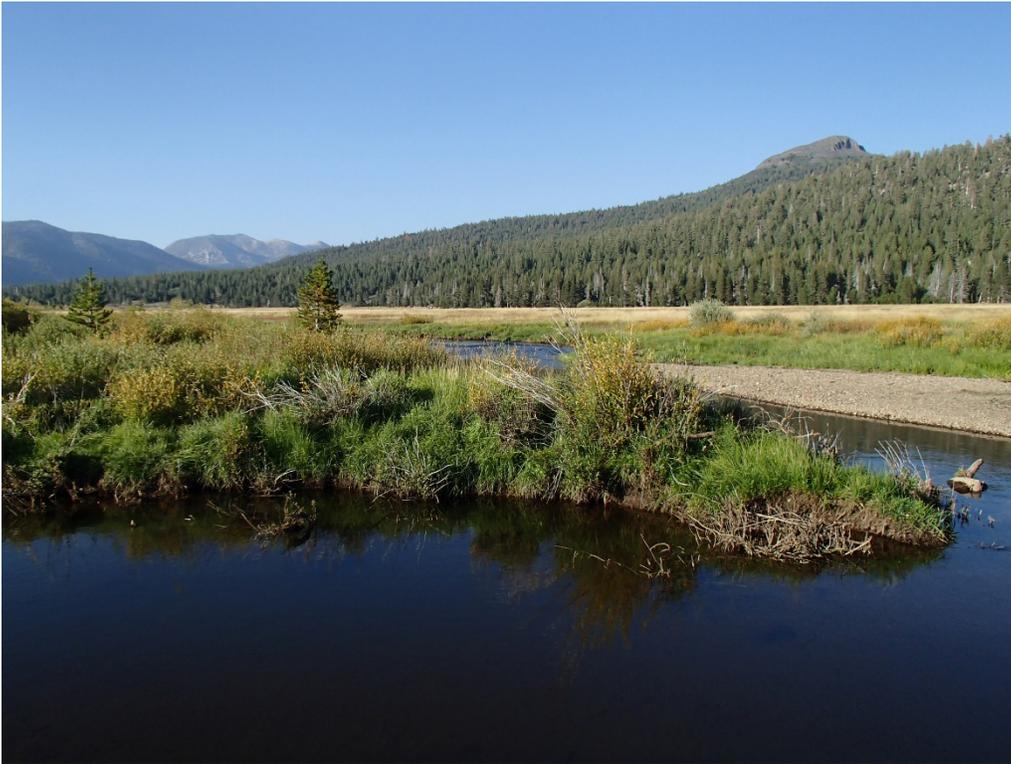
Figure 7. The beaver dam here was end cut by water creating a distinctive backwater and stream bend pattern that can be seen (and continues to evolve) ubiquitously in Sierran Meadow streams that have had beaver present. Photo from Hope Valley, 2017.

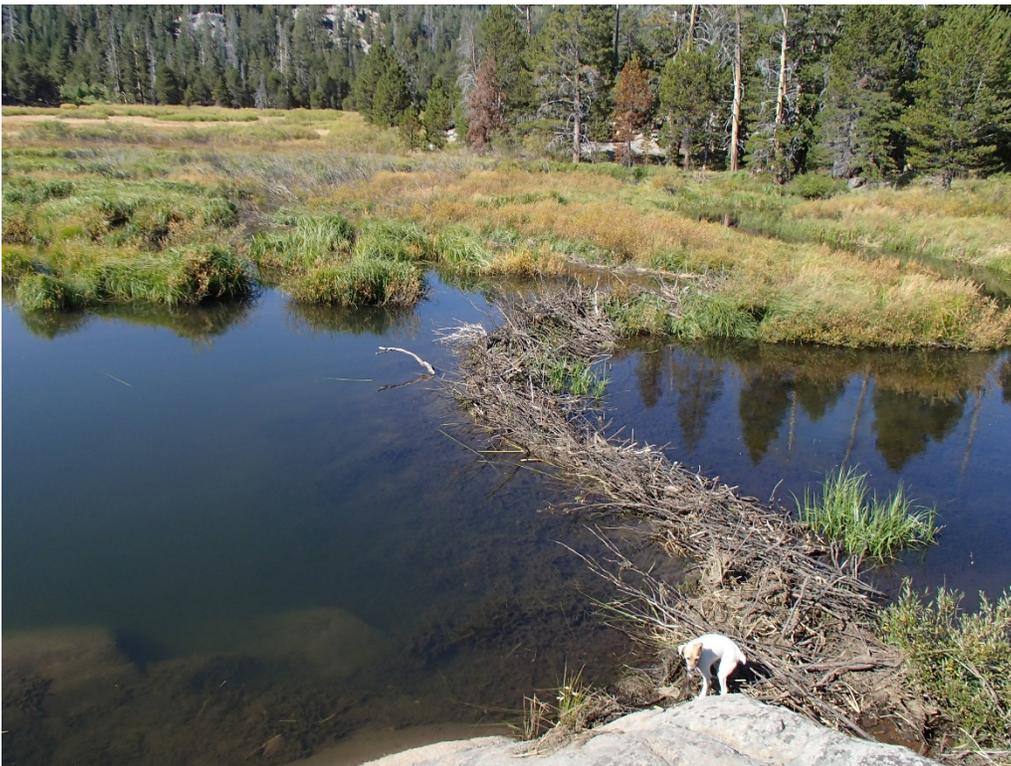
Figure 8. The typical “triangle” shape of a beaver dam with a wide base and narrow top to maximize stability and reduce stream flow. The size and arrangement of sticks within beaver dams is highly consistent and recognizable. Note the multiple flow paths and channels where the stream is backed up into a complex web of channels at a tributary. This dam was breached in winter 2017. Faith Valley, 2016.

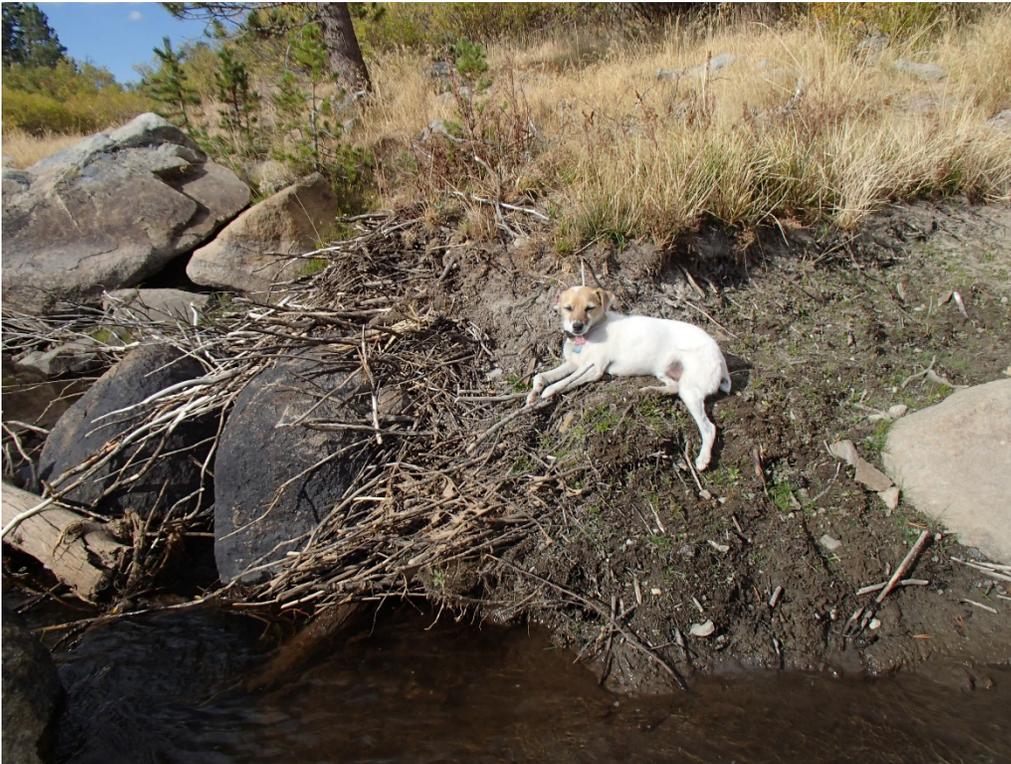
Figure 9. A large remnant dam with beaver sticks remaining in the bank. The size and arrangement is distinct and can be instantly recognized, especially with other clues from the geomorphic influence of the former beaver dam on the landscape. Faith Valley, 2016.

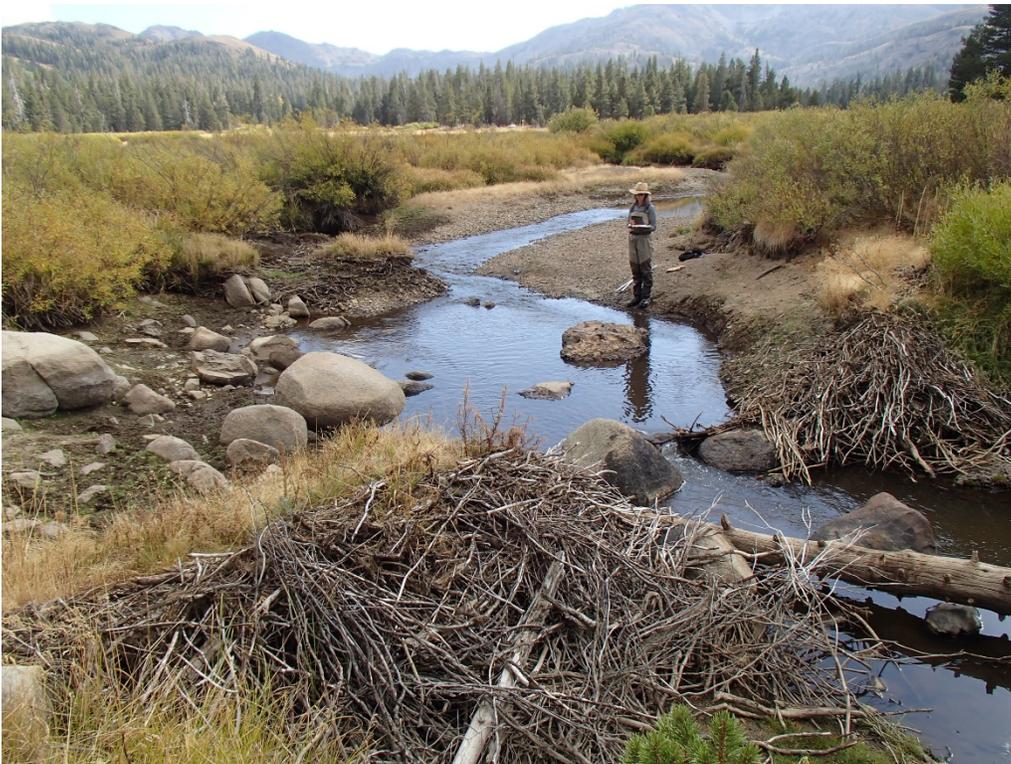
Figure 10. After the dam is breached, the geomorphology of the upstream channel shows the unmistakable influence of the former dam. Sediment deposition, sorting, and fine sediments accreted at the dam margins persist after the dam is no longer influencing the channel. Faith Valley, 2016

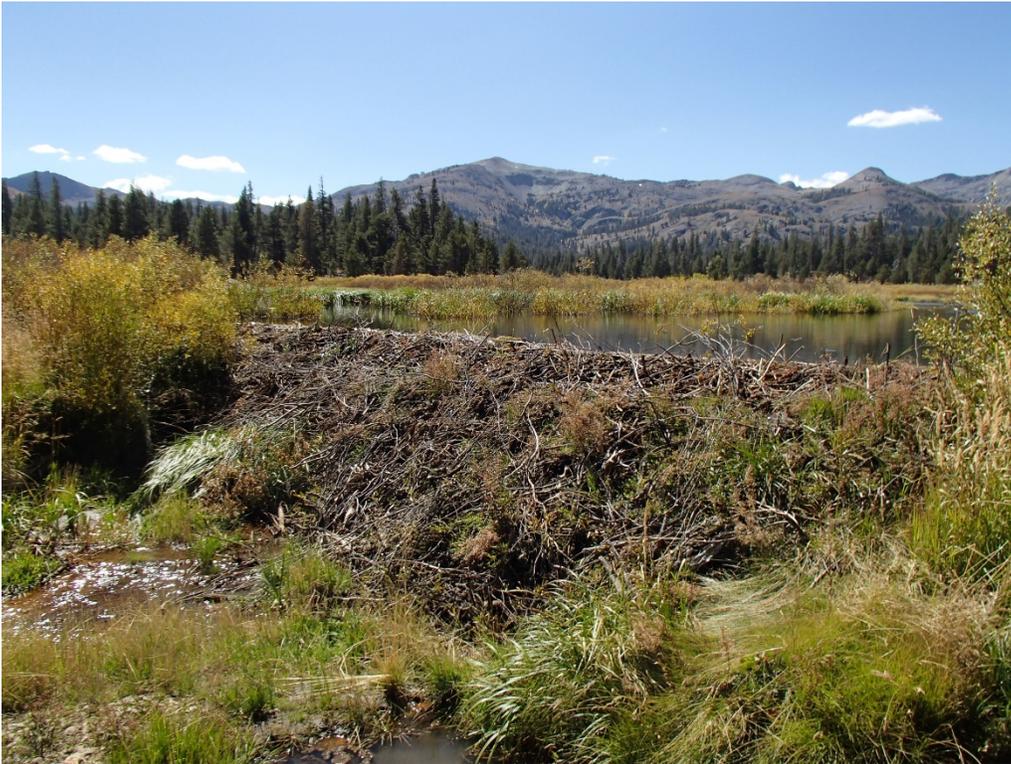
Figure 11. It is common for beavers to repeatedly build large dams at the same site, particularly at confluence areas where the area of inundation can be very large. This dam was breached in the winter of 2017 and exposed dozens of remnant dams in the same area. Faith Valley, 2016

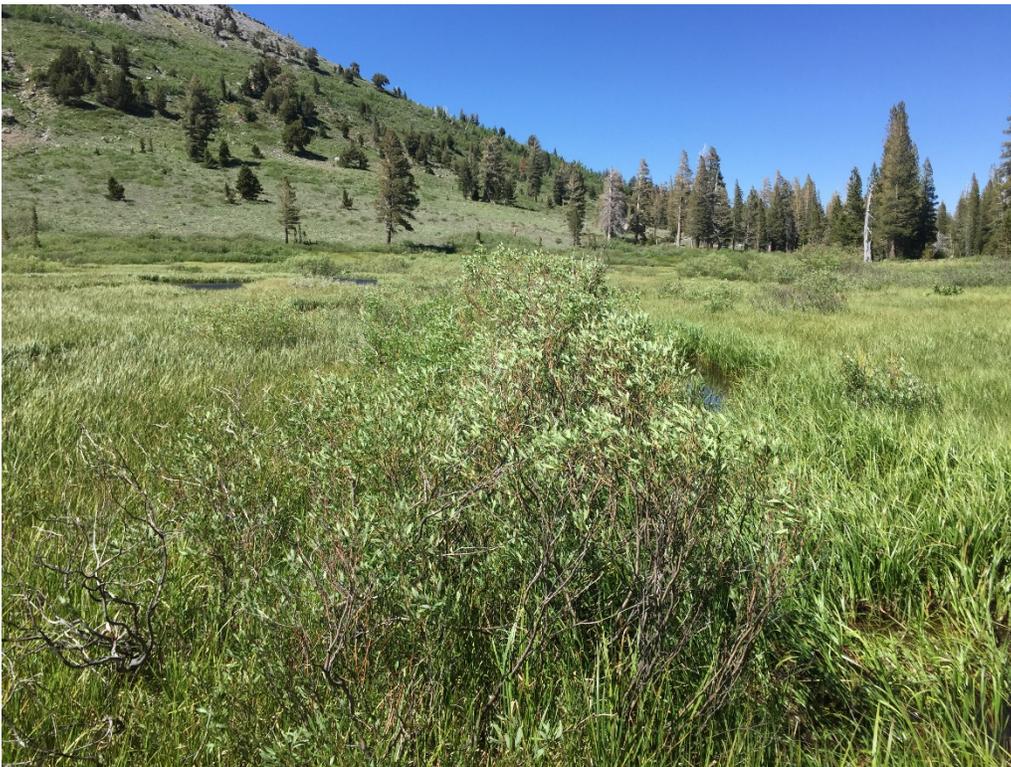
Figure 12. Sprouting willows from a low, cross valley scratch dam have a visually distinct “line” formation that I describe as beavers row cropping. Forestdale Meadow 2018.

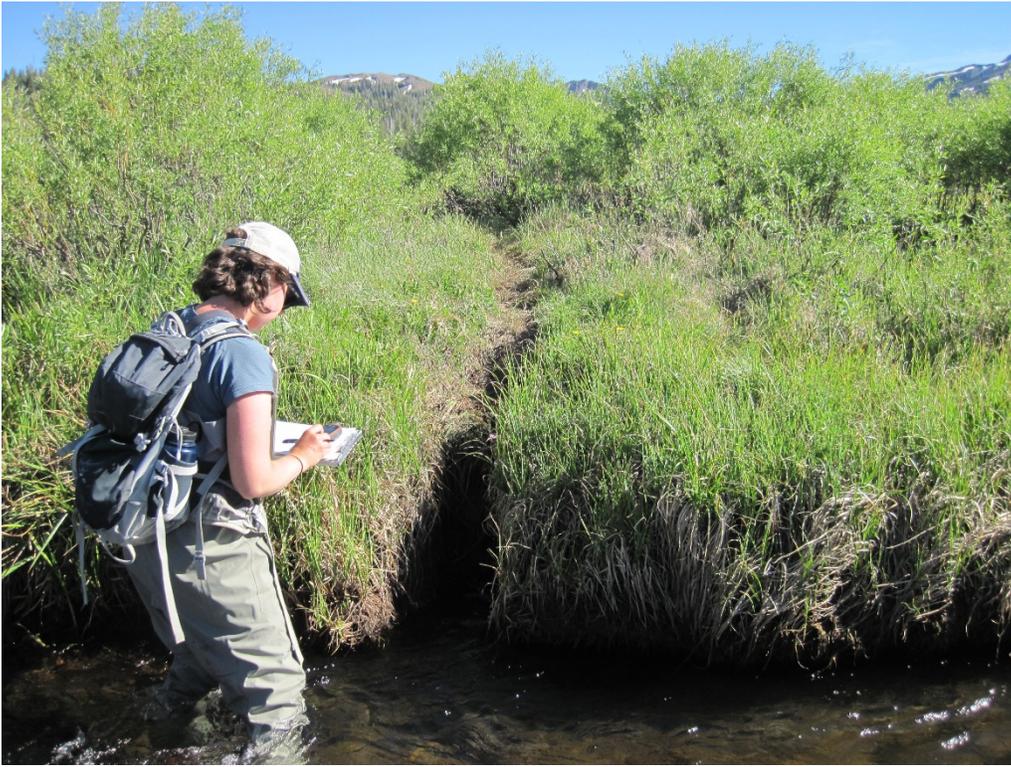
Figure 13. Beaver burrows and tunnels exposed after a dam breach leave a distinctive track that persists for a long period of time. Faith Valley, 2018.

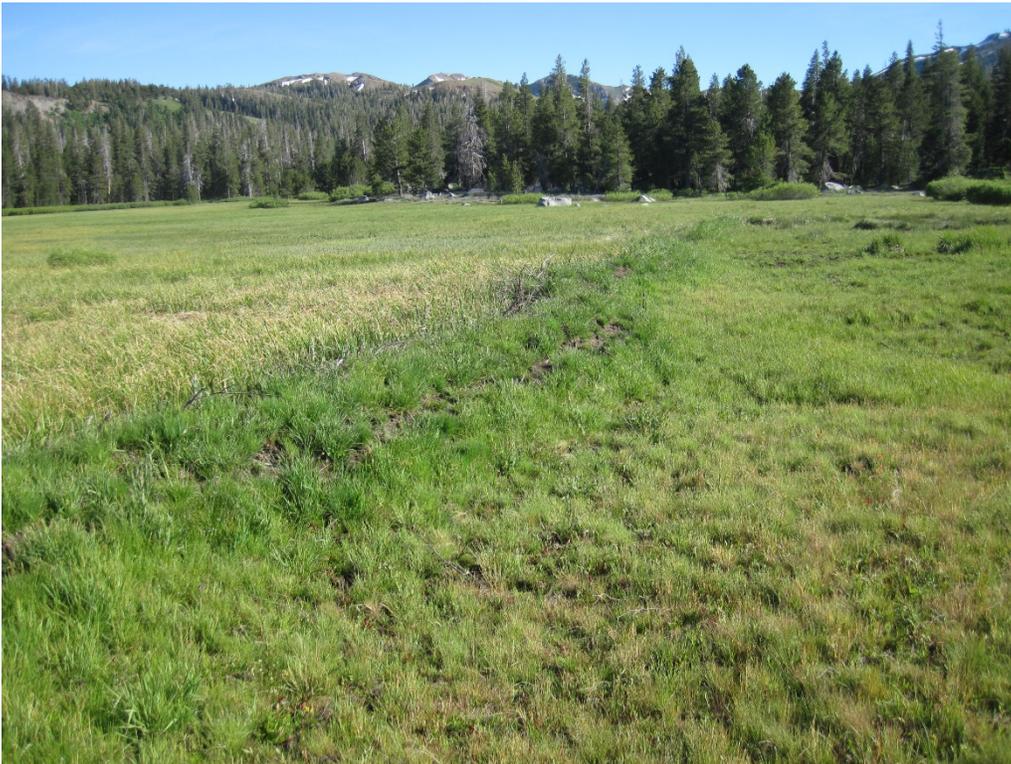
Figure 14. After the dam is breached, this small scratch dam extension across the meadow is left dry and the willows begin to sprout. Faith Valley, 2018.

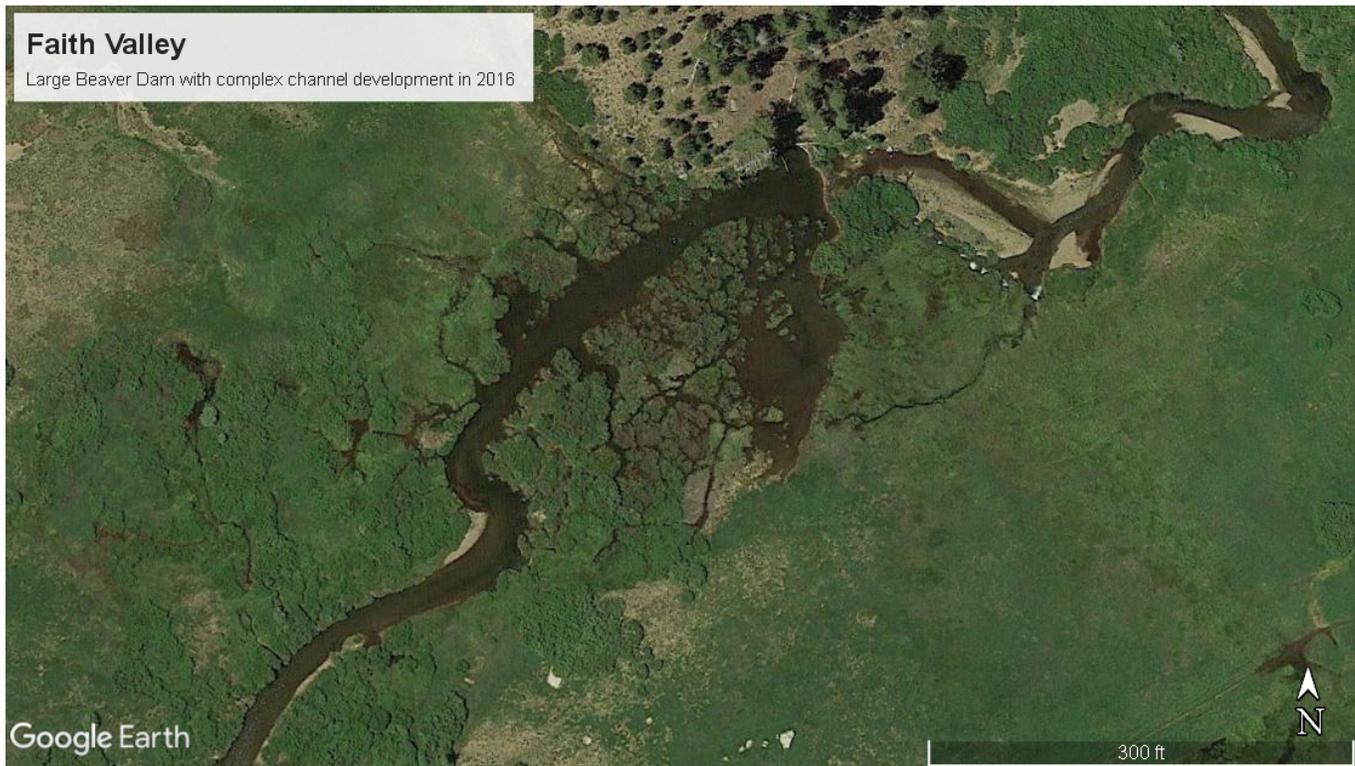
Figure 15. Beavers consistently build a dam in this zone that tends to breach every 3 to 5 years. When a large functional dam is present here it can inundate more than 13 acres with water. This dam was breached in the winter of 2017 revealing numerous remnants of other large dams in the immediate vicinity. Faith Valley.

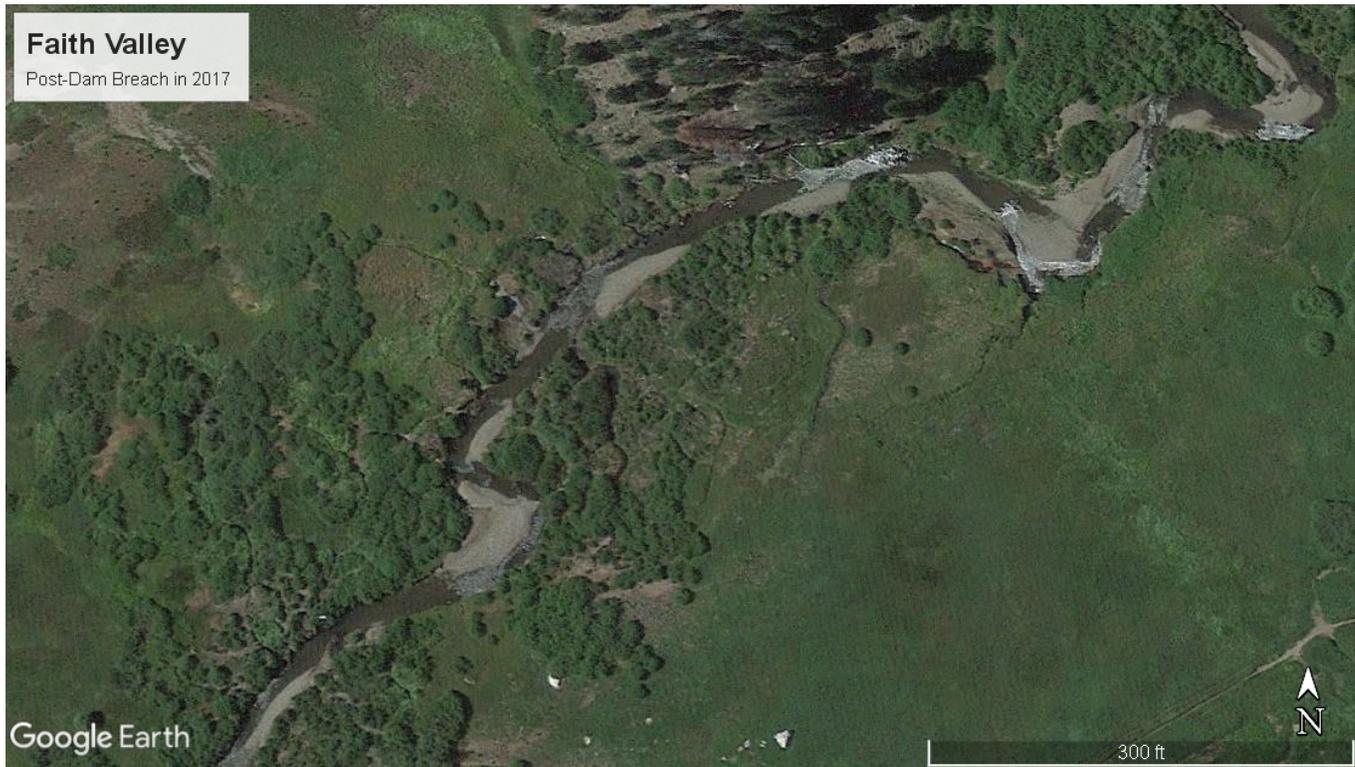
Figure 16. Post-Dam breach in 2017. Note the huge amount of sediment that was trapped behind the dam and was then washed downstream and deposited after the breach. These dynamics of dam building, inundation, breaching, sediment capture and distribution, and willow cropping are essential meadow processes that leave distinct visual remains.
